**Breaking Down the Barriers:  
Making National Hockey League Arenas  
More Accessible**

**Master's Degree Project (MDP)**

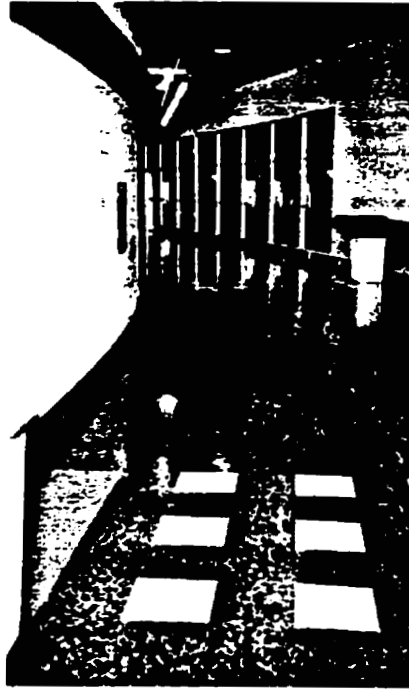
To differentiate between the standard and premium seating areas, all arenas have noticeable changes in texture and floor coverings. In Ottawa, this is accomplished by replacing the polished concrete with linoleum tile (Figure 4.3), which improves colour recognition of specific areas but does little to solve traction problems.

**Figure 4.3 Premium seating area, upper concourse, Ottawa.**

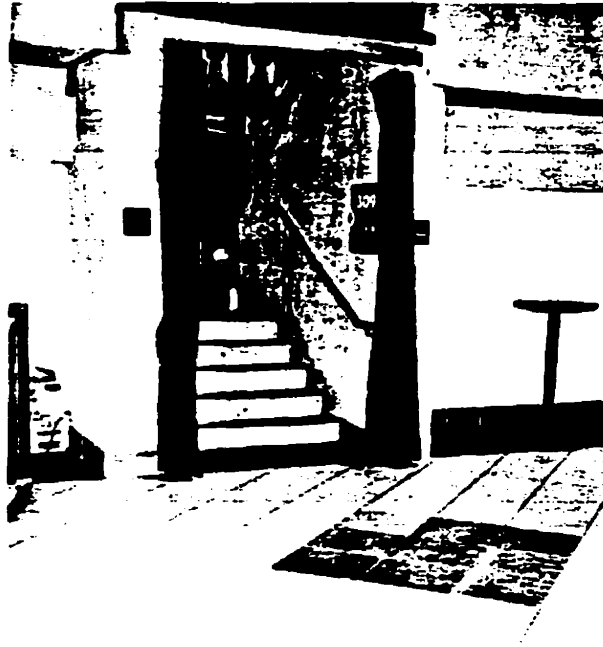
Toronto and Vancouver have chosen to use more highly textured floor surfaces. The floor in Toronto (Figure 4.4) consists of a series of coloured, textured ceramic tiles, with subtle indicators as to access points to the bowl seating area. Such textural cues, however, should be used with discretion because overuse will diminish their effectiveness (Olin, 1983). In addition, the small sign to the left contains the Braille numbers corresponding to the sign above the door and to the right at the bottom of the short flight of stairs, ostensibly enabling all patrons to easily assess where they are in relation to where they want to go. Regrettably, only approximately 10 percent of persons with visual impairments read Braille (Olin, 1983), and additionally, the sign is too small and too low to be effectively utilized in a crowded situation.

**Figure 4.4 Premium seating corridor, Toronto.**

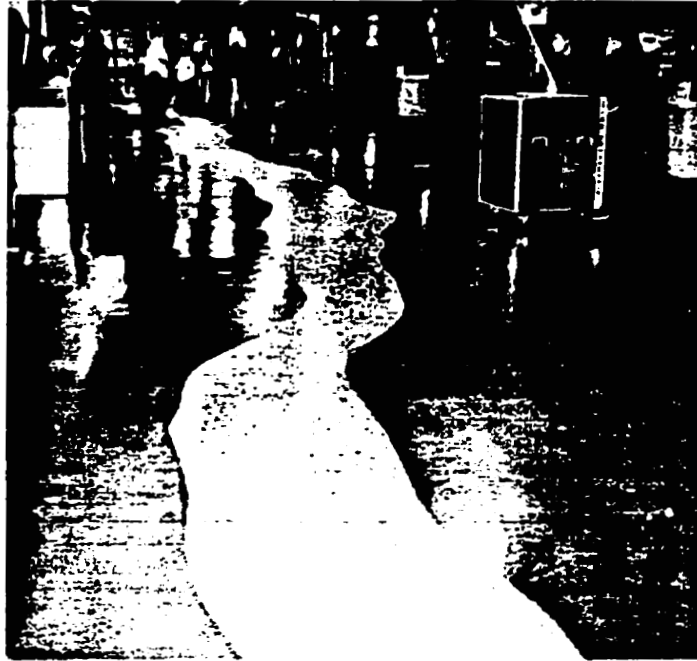
The approach in Vancouver (Figure 4.5) is somewhat less coherent than Toronto's, but as effective. Here, a winding ceramic tile mosaic embedded in the painted cement floor entices patrons into the entrance of the main floor premium seating section; curiously, Vancouver gives the patrons of the higher-priced seats the less appropriate flooring surface, unlike the other arenas visited. Although some glare results from both the painted floor and the ceramic tiles, it did not appear to be problematic in the wayfinding exercises, although for patrons of limited visions, the mosaic might well prove distracting, especially if it was rigidly followed. A more pronounced texture difference would be of great assistance in this regard.

**Figure 4.5 Flooring in Air Canada Club, Vancouver.**

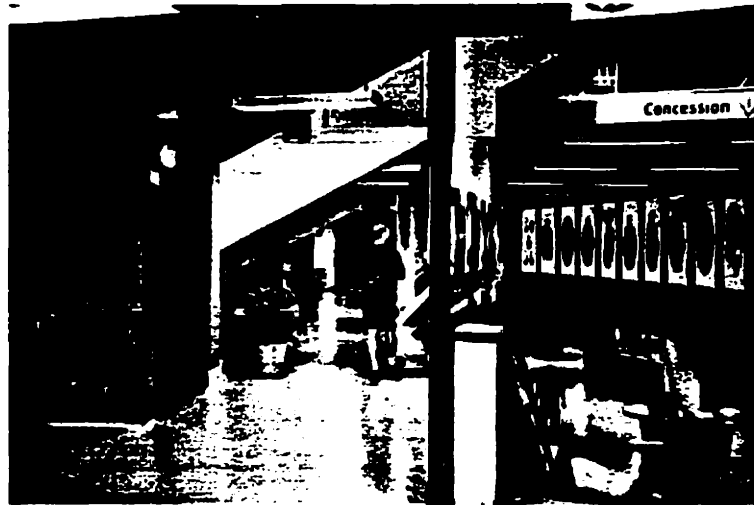
**Figure 4.8 Main public corridor, Montréal.**

While Ottawa makes the attempt at communicating in both official languages, Montréal has obviated the problem by either not posting signage (there is but one to be seen in Figure 4.8, although what little there is in the public corridors consists of easy-to-read black figures on a yellow ground) or by not keeping signage maintained. For a relatively new facility, Figure 4.28 shows how the signage (with large type in French and small type in English) has degenerated to the point of being practically unreadable.

Of some concern were several instances of restricted headroom areas in the facilities, primarily caused by intruding staircases. While this might be expected in an older venue such as Edmonton (Figure 4.6), it is also an issue at Toronto (Figure 4.7) in some isolated places, and throughout the main corridor in Montréal (Figure 4.8). Article 3.4.3.6 of the NBC mandates headroom clearance for stairways to be not less than 2.05 m, but for persons with visual perception difficulties, this

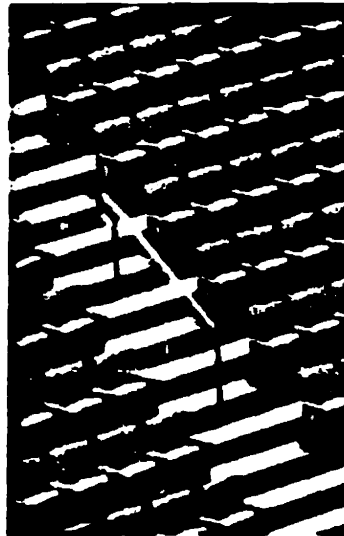
Of the venues examined, Montréal was the only one found to have handrails throughout the entire lower bowl area (Figure 4.9). While they are not continuous, and do not have a second, lower handrail for smaller adults and children, they are still of great assistance to patrons.

**Figure 4.9 Handrail in lower bowl area, Montréal.**

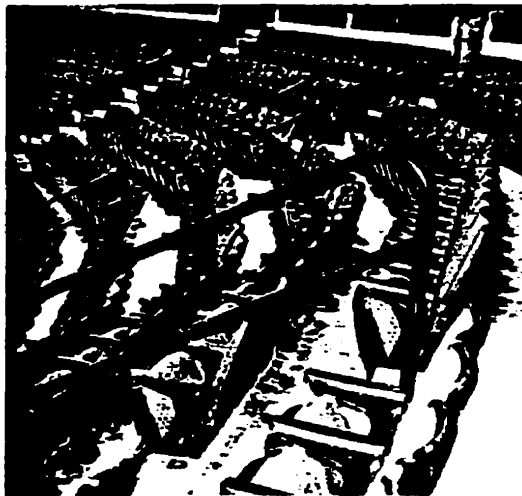
Of the remaining facilities, Toronto and Ottawa (Figure 4.10) had handrails at the upper edges of the lower bowl area, while all arenas had handrails in the upper level seats, where the angle of the seating area was greater than 50°. An excellent example of such stairs is displayed in Calgary (Figure 4.11), where reflective and textured strips, the handrail, and prominent row and seat markings are integral, well-designed (including curved ends to reduce the hazard of sharp edges), and thoughtfully executed.

**Figure 4.10 Handrail in upper main bowl area, Ottawa.**

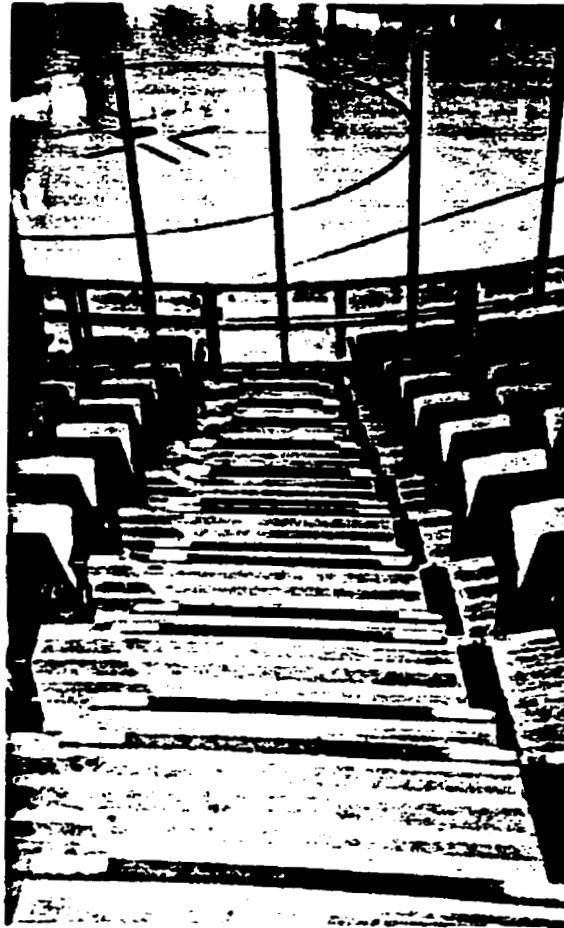
Where handrails are not provided in the lower bowl area, other methods of assisting patrons are employed. At a long flight of stairs in one corner of Edmonton (Figure 4.12), a series of reflective strips and contrasting-coloured textured strips mark the treads on the metal steps. With all the ushers equipped with flashlights, such strips are effective in guiding patrons, although this system becomes less effective in crowded conditions.

**Figure 4.12 Reflective strips on stairway in lower bowl, Edmonton.**

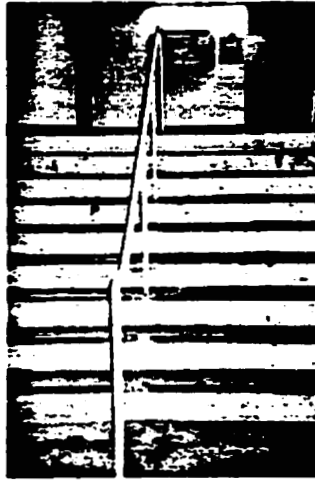
Not dissimilar is the treatment of the staircases outside of the bowl area in Toronto. Because banks of elevators, staffed with operators, are the prime movers of people between floors, the staircases are primarily used only for emergencies and at the end of the game, when patrons no longer wish to wait for an elevator. Even though they are primarily utilitarian in this regard, and have only one handrail, they are well-textured and lit, with frequent windows to provide outside views (Figure 4.16).

**Figure 4.16 Main staircase in interior corridor, Toronto.**

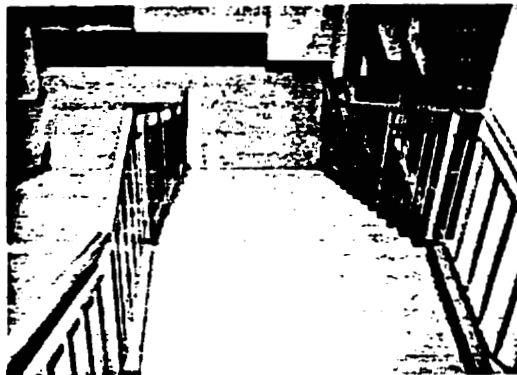
In this regard, Vancouver is perhaps the venue that has done the most in providing information via reflective treads as to the position of top and bottom stair treads (Figure 4.17) to assist in patrons finding their way. Edges of the floor and stair areas are painted a different colour, and have additional texture added to them to alert patrons when they are near the wall.

**Figure 4.17 Staircase and painted/textured floor, Vancouver.**

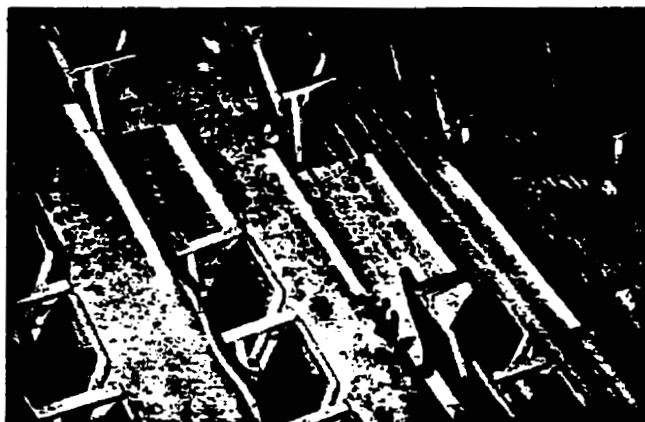
Even for persons with excellent vision, this is a most disconcerting experience, and several patrons noted that despite having season tickets in the area, they still had difficulty with descending, especially when loaded down with concession items.

**Figure 4.18 Transition area, Calgary.**

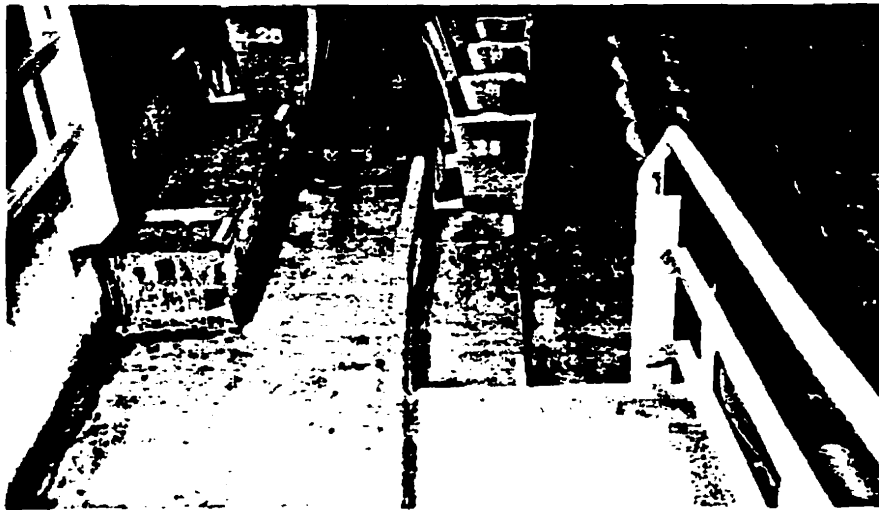
There are two problematic situations in Edmonton. The first is at the entry to the lower bowl from the main public corridors and is illustrated in Figure 4.20. Here, the extant condition requires patrons to negotiate several small steps, a series of awkward turns, locate the main stair, and descend, looking for their row number. In the case below, there is also a dearth of handrails and textured treads, although the area is well-signalled with reflective strips. Ushers interviewed in this area indicated that patrons frequently misstep in the area, with two or three injuries requiring medical assistance occurring almost every game.

**Figure 4.20 Stairs in lower bowl, Edmonton.**

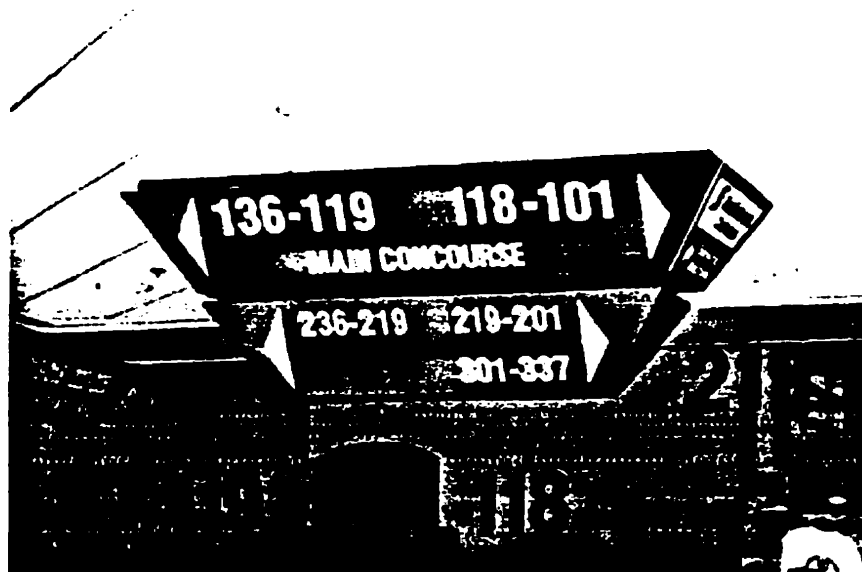
One of the first tasks a patron undertakes when attending a game is to find the seat that has been purchased. Edmonton (Figure 4.29) provides clear directions in the main corridor area that enable patrons to quickly and easily determine the direction they need to locate to find their section. Once reaching the appropriate section, flashlight-bearing ushers are available to assist patrons to find their seats; given that the row and seat numbers are not particularly prominent, and the stairways can be problematic, management of the facility has decided to address their shortcomings by providing people to perform tasks that could be served by improved design and building standards. While this is an expensive solution in terms of worker salaries, it is, nevertheless, a practical one, given the extant situation.

**Figure 4.29 Seat directional signage in main concourse, Edmonton.**

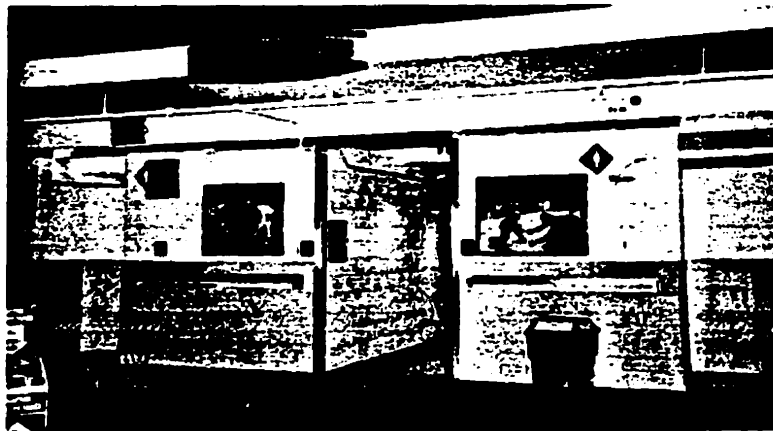
There is good and bad news regarding finding bathrooms in Toronto, in addition to the situation noted above. The good news is that in the main public areas, there are also signs noting the location of the next nearest washroom, as a convenience to patrons; the bad news, illustrated in Figure 4.33, is the inability to discern at a distance which doors services which gender (men are the one door to the left with a second door not visible, women have the two doors on the right, but unless a person is standing within 3 m of the sign, it is extremely difficult to determine).

**Figure 4.33 Men's and women's bathrooms, Toronto.**
