Groundwater use in the high valley of Cochabamba, Bolivia

An inventory on water quantity, water quality and users perspective

BSc Thesis Arthur Heijstek, registration number: 920702-338-010

Bachelor thesis Water Resources Management submitted in partial fulfillment of the degree of Bachelor of Science in International Land and Water Management at Wageningen University, the Netherlands

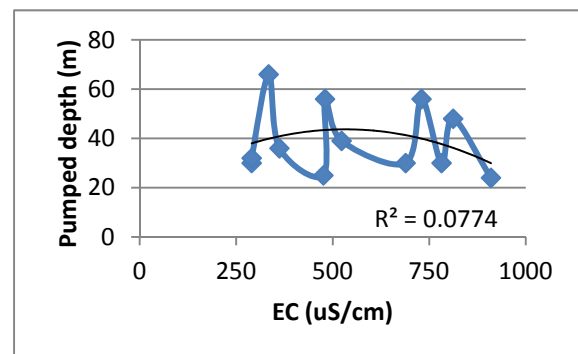
Figure 7 Relationship EC and pumped depth (trend line: polynomial)

Since there is high variety in EC values, the values have been plotted spatially in figure 8 and have been compared with the pumped depth in figure 7 to see if the deviations in values can be explained. However both figures indicate that based on these data there is no clear zoning of EC values spatially (see figure 6) or a clear relationship between EC and pumped depth (see figure 7, $R^2=0.08$).

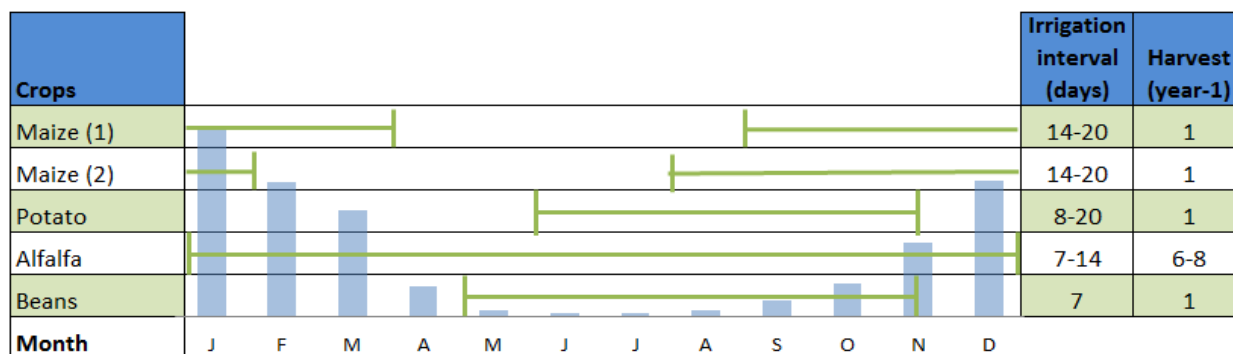
The crops that 20 interviewed farmers irrigate with groundwater are displayed in figure 8. All farmers that were interviewed irrigated their crops through flood irrigation. Results show that in general farmers use two different growing seasons for Maize, respectively from September till March and August till February. Potatoes are mainly irrigated from July till mid-November, alfalfa the whole year round used for forage and beans are grown between March and mid-November. A general farmers strategy concerning potato and field beans was discovered, namely: farmers state that potatoes and beans are more sensitive to water logging then Maize and therefore grow these in the dry season so they can control the quantity of water supply exactly by irrigating with groundwater.

Figure 8 Crops irrigated in Cliza, own elaboration displayed on the division of average monthly rainfall, source: Municipio de Cliza (2010)

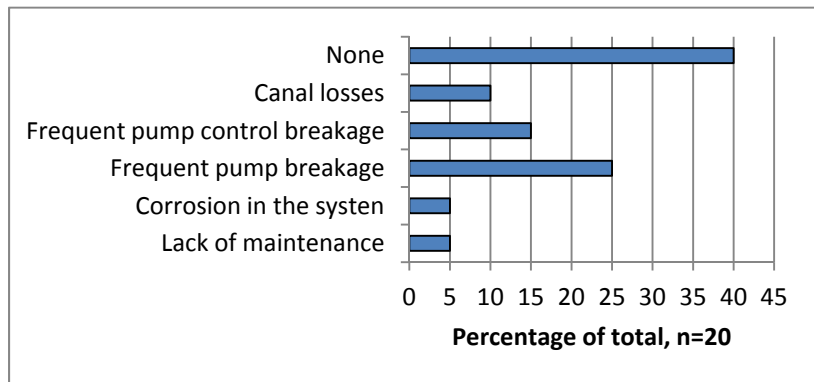
Figure 10 Problems with functioning of a well and/or water distribution network

In figure 10, primarily it becomes clear that frequent pump and pump control breakage are the main experienced problems. Besides this, canal losses, corrosion in the system and a lack of maintenance are experienced problems. Finally 40% over the 20 interviewees stated to have no experienced problems.
