**Rehabilitation of HC-Type Bridge Girders Using CFRP-Sheets/ Strips or
External Post-Tensioning**

Amr H. Riad

A THESIS

DEPARTMENT OF CIVIL ENGINEERING

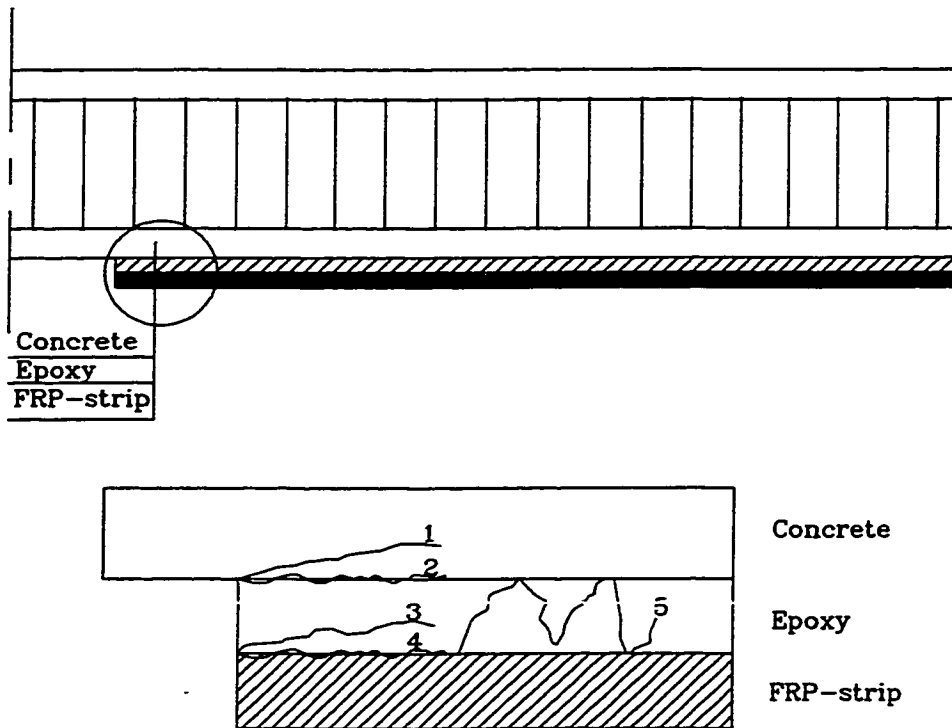
- 1: Peel failure into concrete
- 2: Interfacial failure between concrete and adhesive
- 3: cohesive failure in the adhesive
- 4: Interfacial crack between the adhesive and the composite
- 5: Alternating crack path between the two interfaces

Figure 2.2 Potential Crack Paths

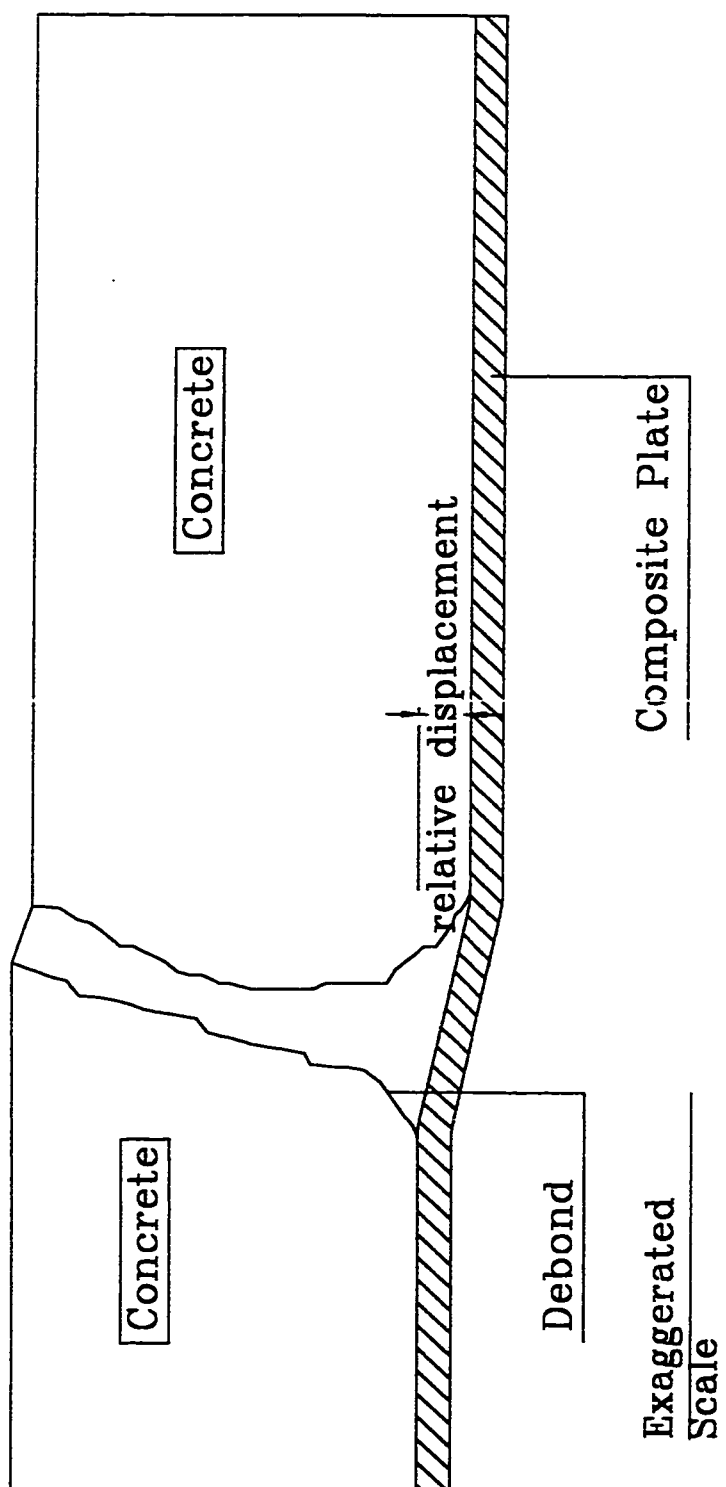
Figure 2.3 Schematic of failure mode in debonding due to relative movement and interfacial debonding at the concrete-composite

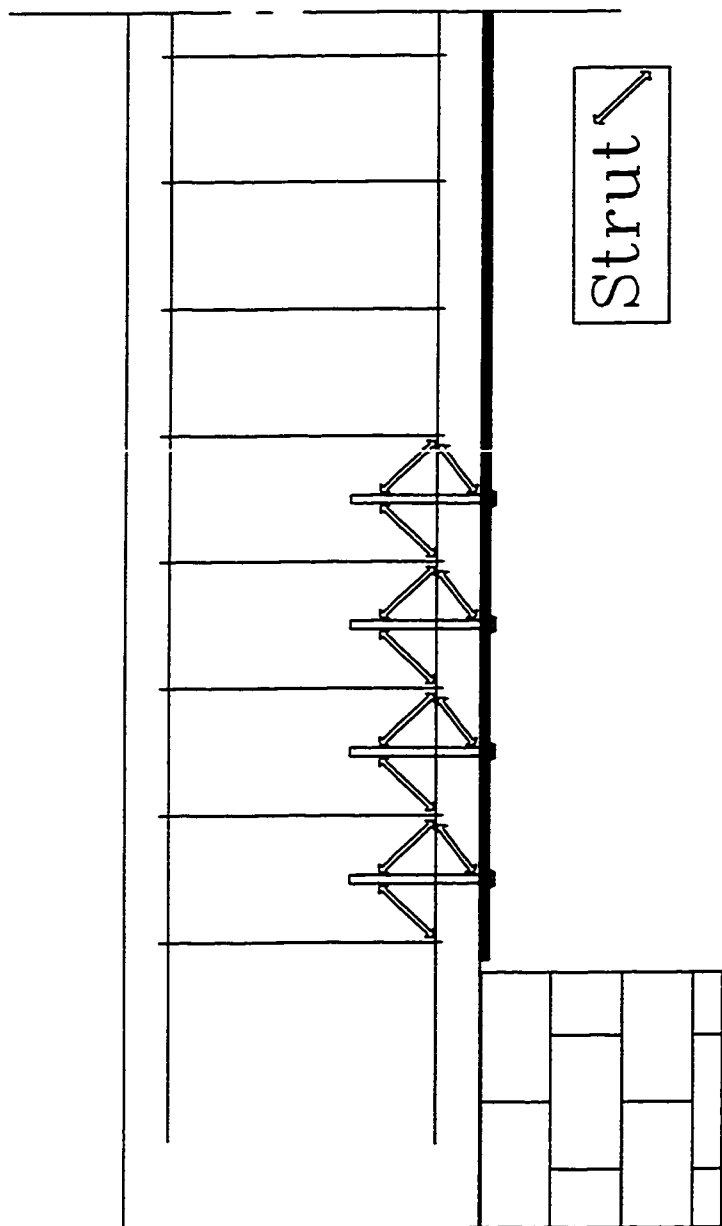
Figure 2.5 The Strut and Tie Model Suggested by Pichler (1993)

It seemed that due to lack of “suspension reinforcement” (extra external vertical reinforcement to transfer the forces from the level of the steel plate to the compression zone) several cracks were formed in the level of the plain concrete between the level of the reinforcing bars and the level of the steel plate, forming concrete struts, not finding steel

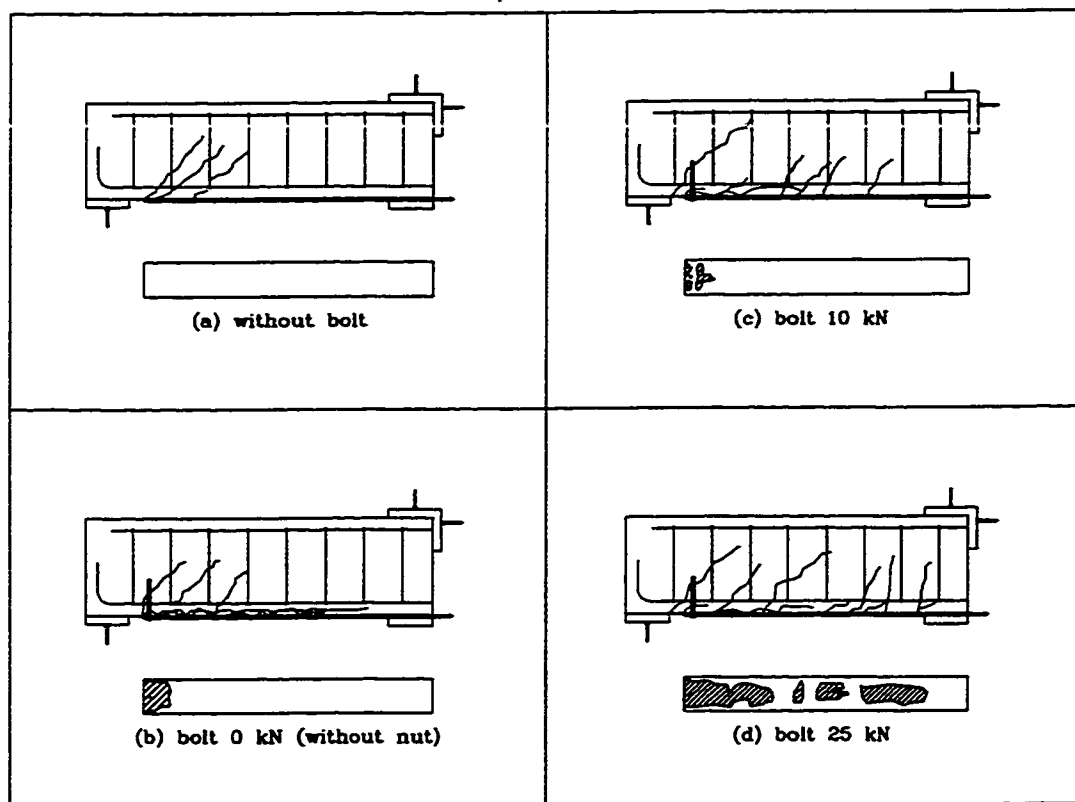
Figure 2.6 The effect of the Prestressed Bolts on the Mode of Failure of the Beams

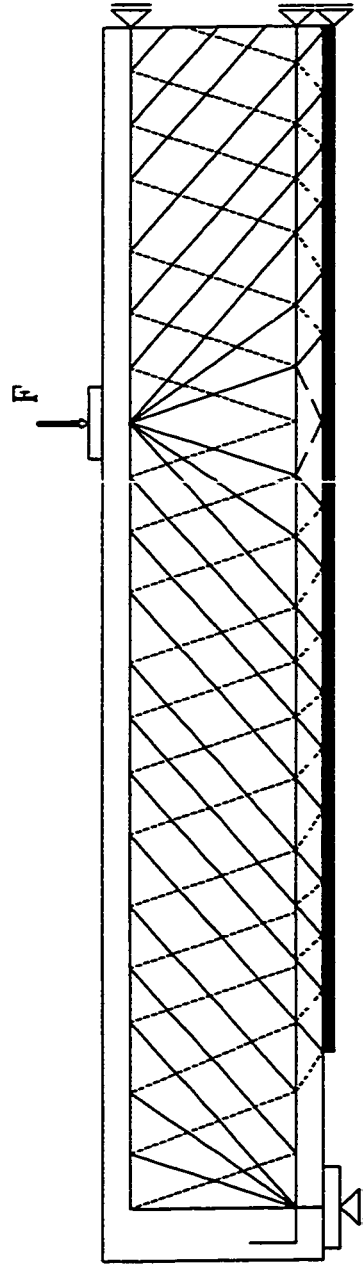
Dashed lines represent compression struts

A numerical truss model (Figure 2.7) was developed by the author, taking into consideration that the materials have non-linear properties in the plastic state. The focus of the numerical model was to concentrate on the ends of the plate to analyze the principal stresses in this area to verify the experimental work and produce general equations.

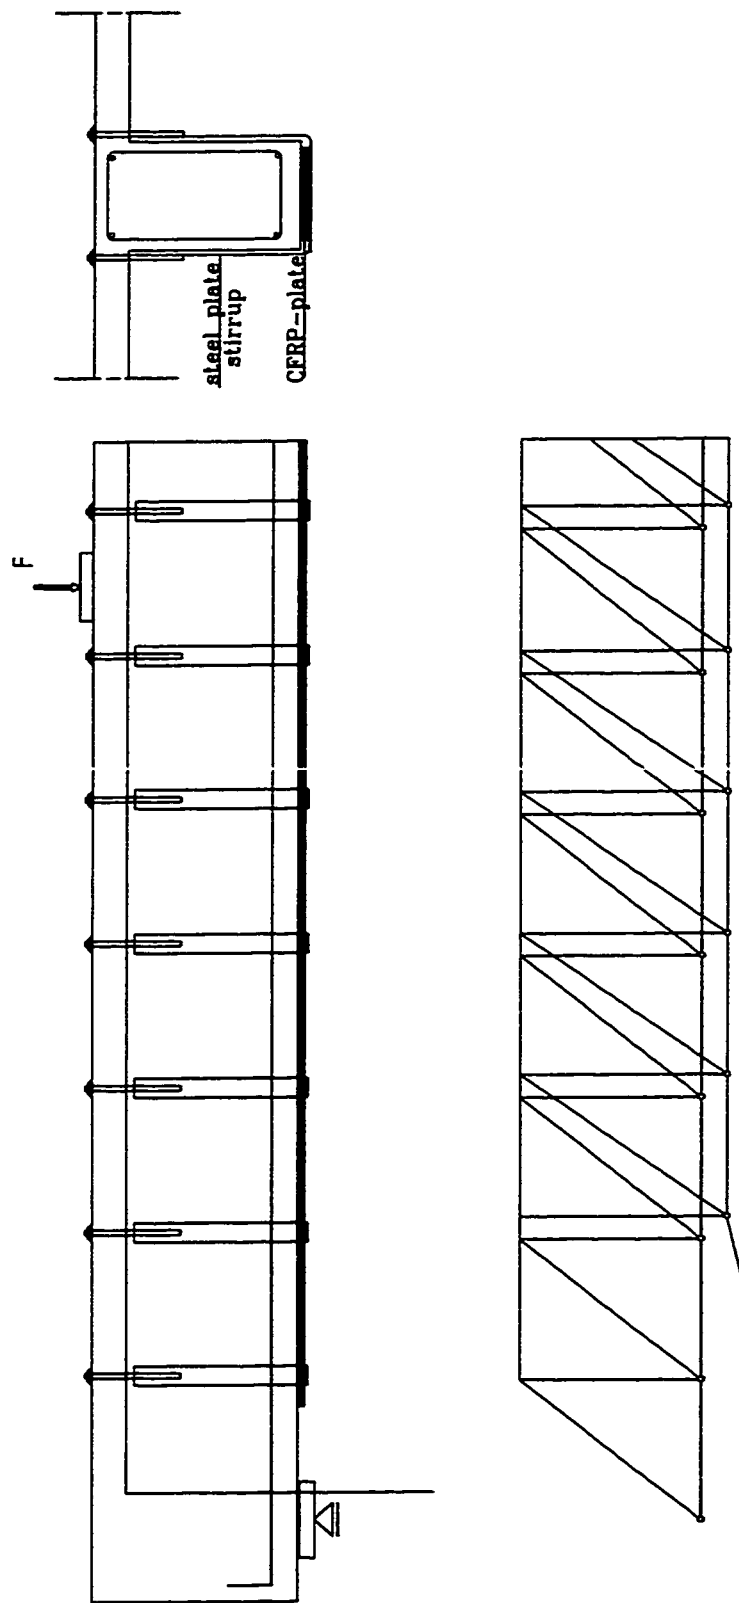
Figure 2. 8 Truss Model and Proposed Method of Rehabilitation

The design procedure used for bending is the same procedure used in conventional design for reinforced concrete. Some limitations, resulting from experimental results, for the strain were established by the authors in order to prevent separation of the plate from the concrete

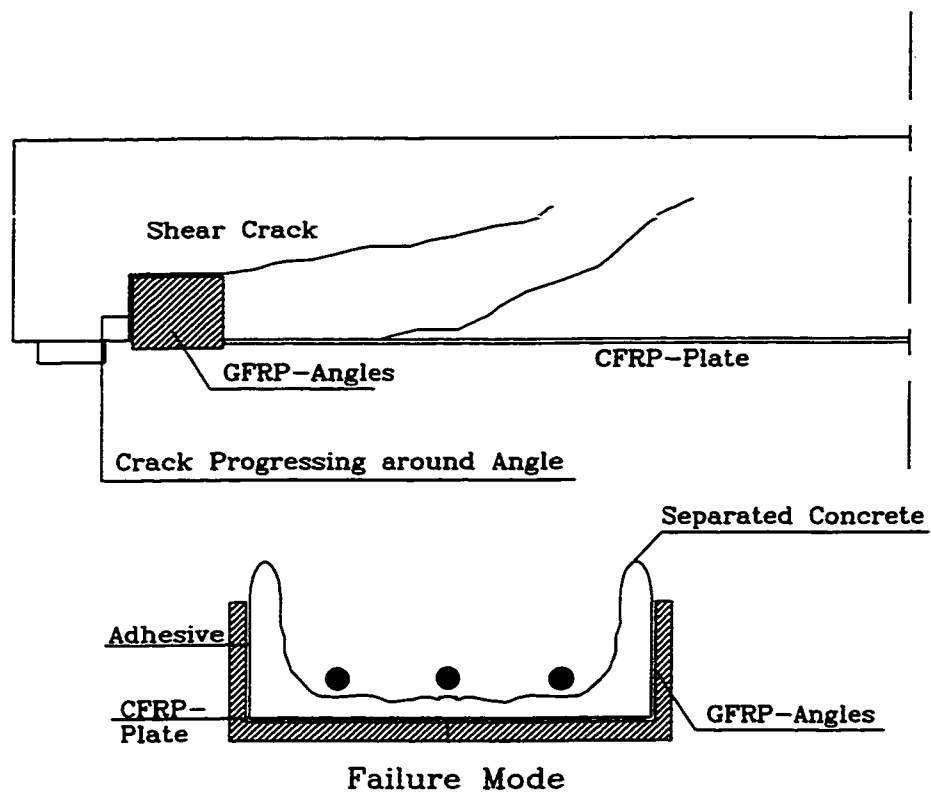
Figure 2.9 The End Anchorage and The Cracks at Failure, Garden et al. (1997)

Some important results were observed and conclusions drawn from the tests. In all plated cases, failure was accompanied by separation of concrete cover from internal reinforcement as shown in Figure 2.9. This type of failure means that the concrete itself, being the weakest material in the composite section, fails before the plate and the adhesive. The results also indicated that the anchorage system is a very important issue and the stronger the anchorage system is, the higher the capacity of the beam will be. It turned out that the highest capacity is reached with full anchorage of the plate between the plate and the supports, which is not practical in the field: beams would have to be jacked off their supports in order to place the strips between them and the support, which is expensive. Another important issue is the aspect ratio of the plate itself. It turns out that the thin wide plate develops a higher capacity in the beams than the thick narrow one (provided they have the same cross-sectional area). The composite action of the plates and the concrete was examined in the tests. Strain profiles were drawn and the plates generally produced a strain equal, or very nearly equal, to the strain in the bottom of the beam. The neutral axis position was noticed to be lower in plated beams than in unplated beams, which indicated a higher compression zone in the concrete to balance against the tension in the plated beams. Observing some results of shear forces at ends of anchored plates and comparing them with the calculations based on the elastic theory; it seemed that the elastic theory underestimates the bond stresses between the plate and the concrete. The author states that the failure due

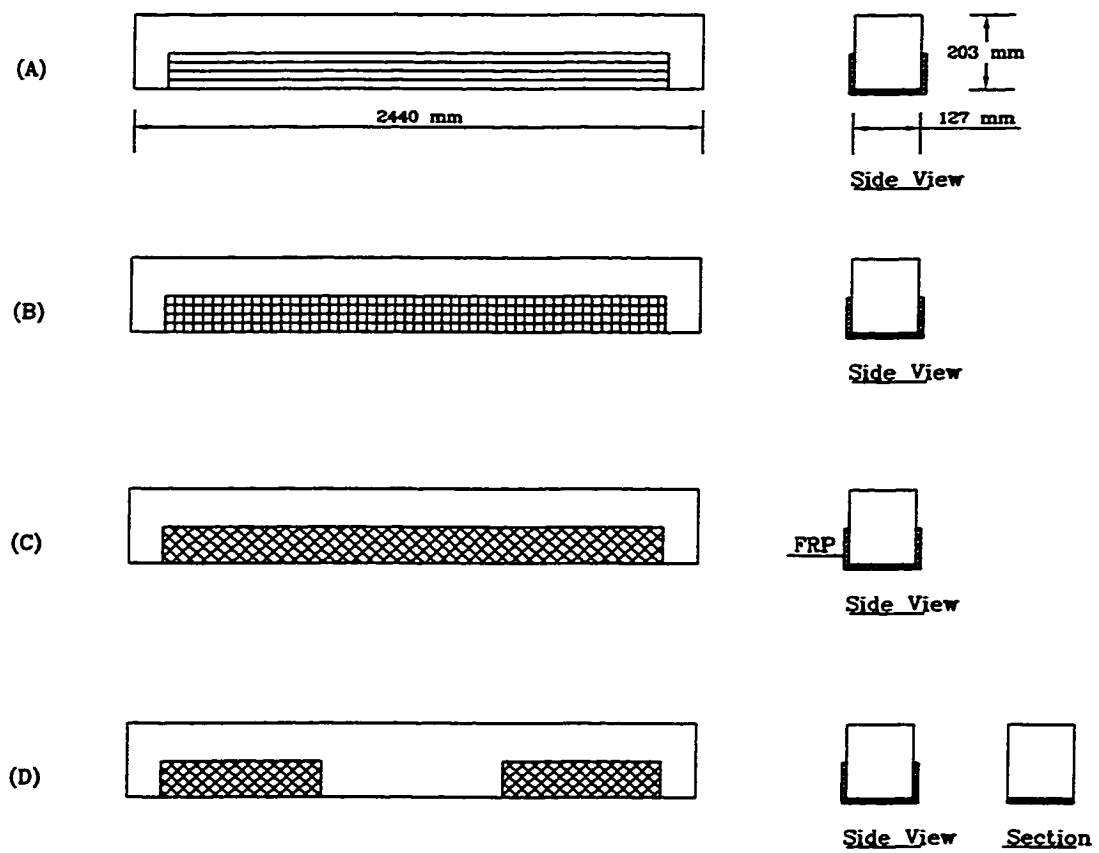
Figure 2.10 The Different Orientations of Fibres in Flexure Test

The testing programme included 13 beams with a span of 2440 mm tested for flexure (Figure 2.10) and six beams with a span of 1220 mm tested for shear (Figure 2.11). There was a little difference between the various sorts of fibres used; the continuous fibre sheets behaved much like the stitched or the woven fabrics. There was no difference between the precracked beams and the uncracked ones at the ultimate level. The previous

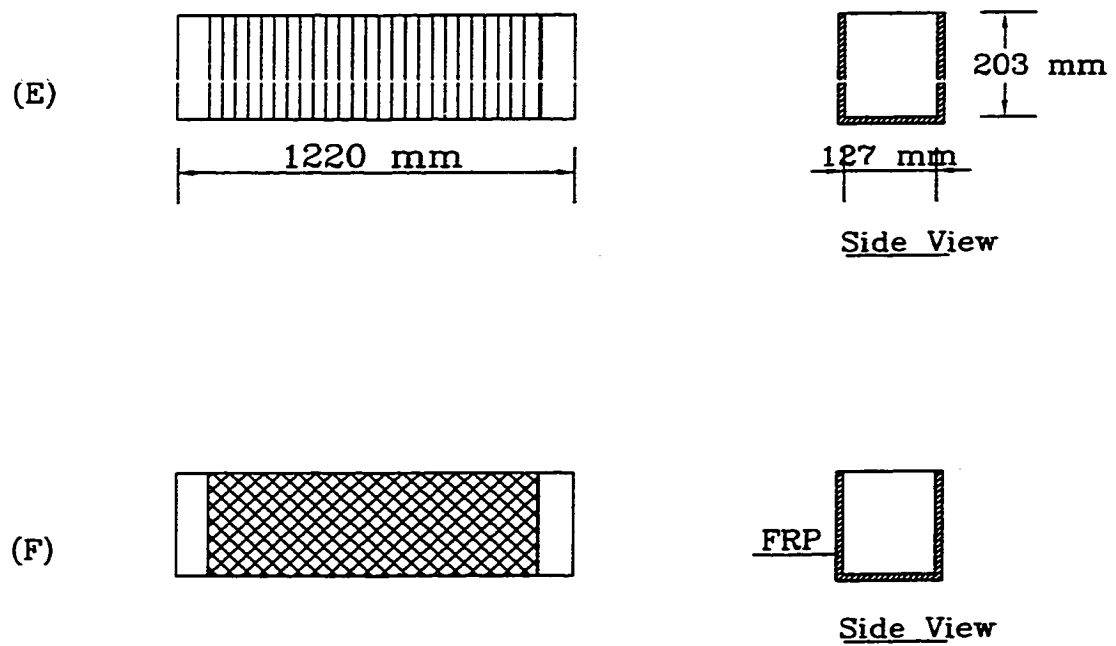
Figure 2.11 The Different Orientations of Fibre used in Shear Test

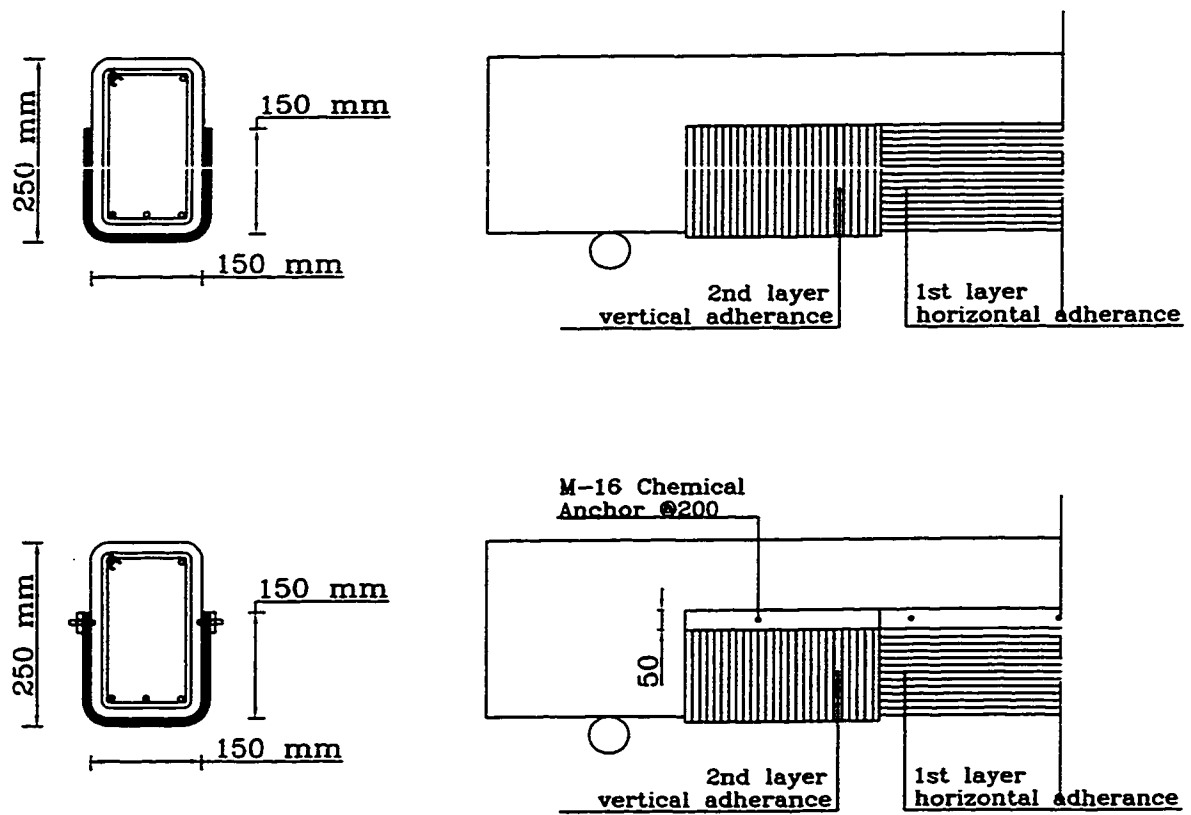
Figure 2.12 Alignment of CF-sheets in the Beams tested

Tests performed on prestressed concrete I-girders wrapped with CFRP-sheets by Drimoussis and Cheng (1994), Cheng, Hutchinson and Rizkalla (1997), were aimed at determining the increase in the shear strength of I-girders. Different types of sheets were applied at different locations and at different angles on the beams. In some tests the sheets were glued vertically on the webs of the beams, while in others the sheets were placed horizontally. Sheets were also applied at inclinations of 45 degrees, crossing each other. This latter configuration was found to give the maximum shear capacity for the P/C beams. The increases in capacity obtained were in the range from 9% to 56%. The main problem encountered was bond failure between the CFRP-sheets and the reinforced concrete.

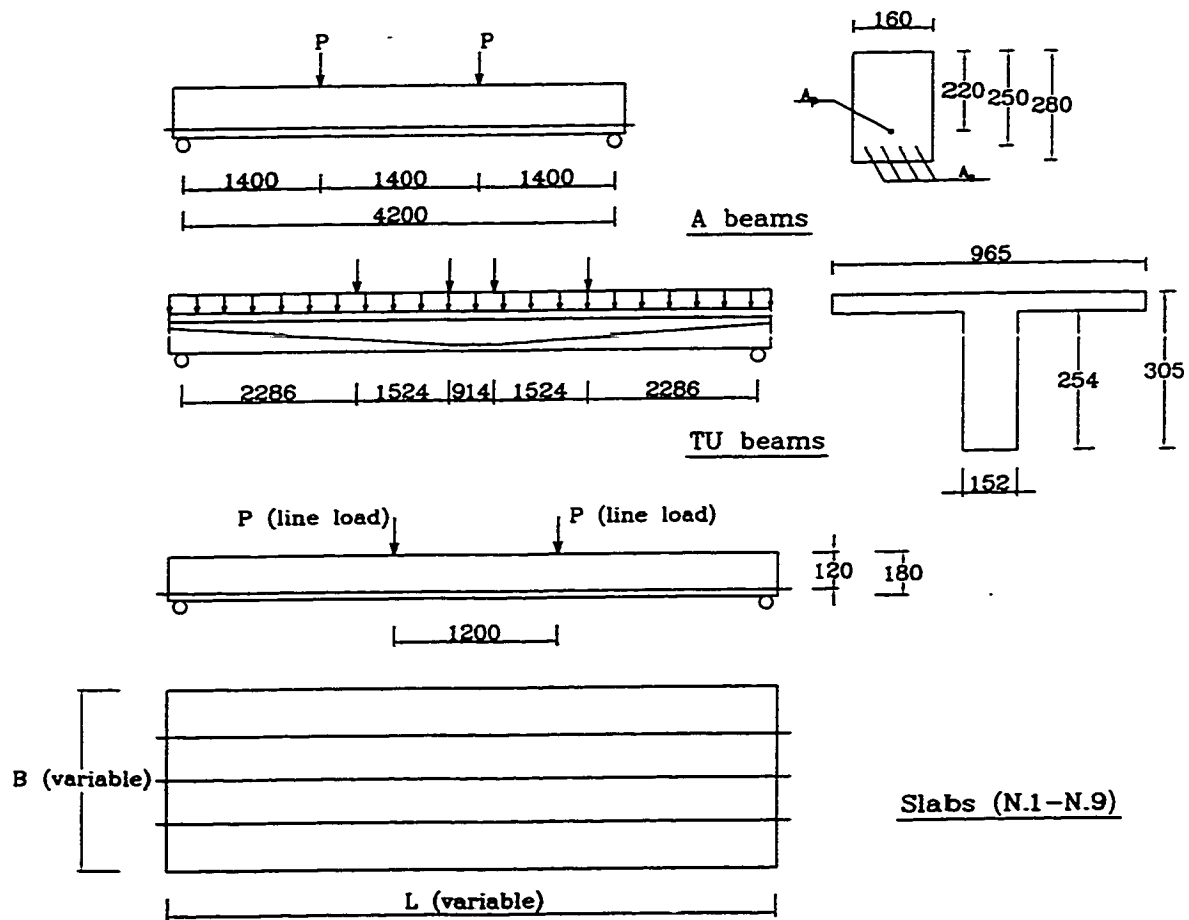
Figure 2.13 Experimental Verification of Mathematical Model

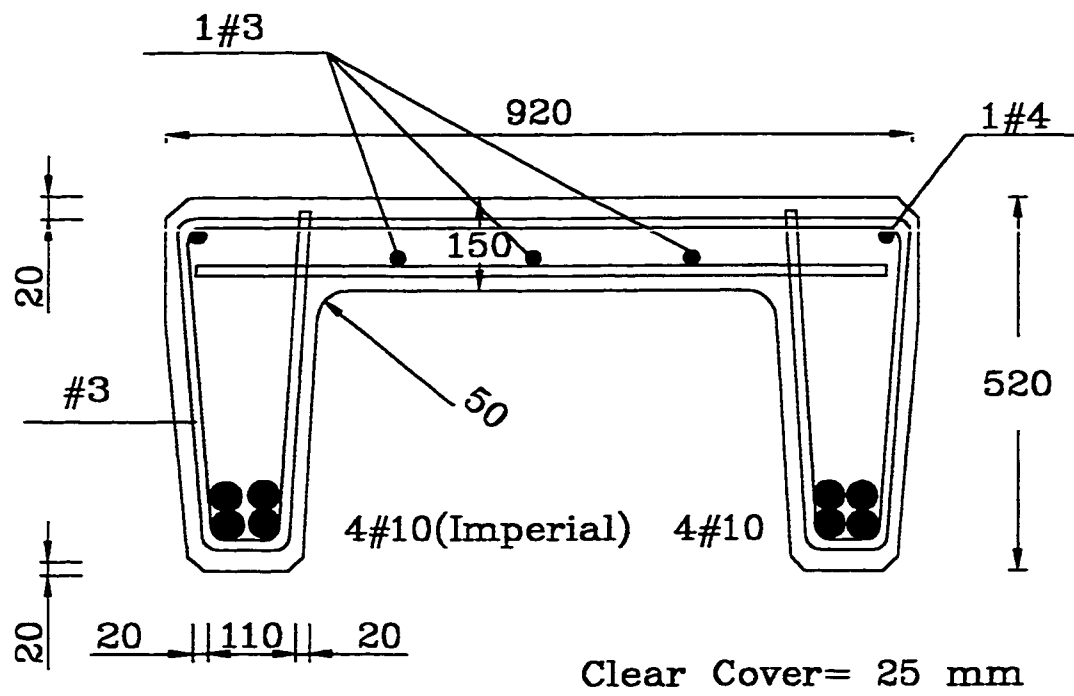
Figure 3.1 Girder HC-Type

The project involved testing 8 precast reinforced concrete HC-type beams. The length of the beams was 11.6 m: the cross section is shown in Figure 3.1. Each beam had two diaphragms, one on each end. Non-destructive tests were performed with a Schmidt

Initial calculations of the flexural resistance and expected deflection at failure of an undamaged beam with the cross-section as already shown in Figure 3.1 were made to ensure the testing apparatus was adequate for the tests. Also, these calculations provided a

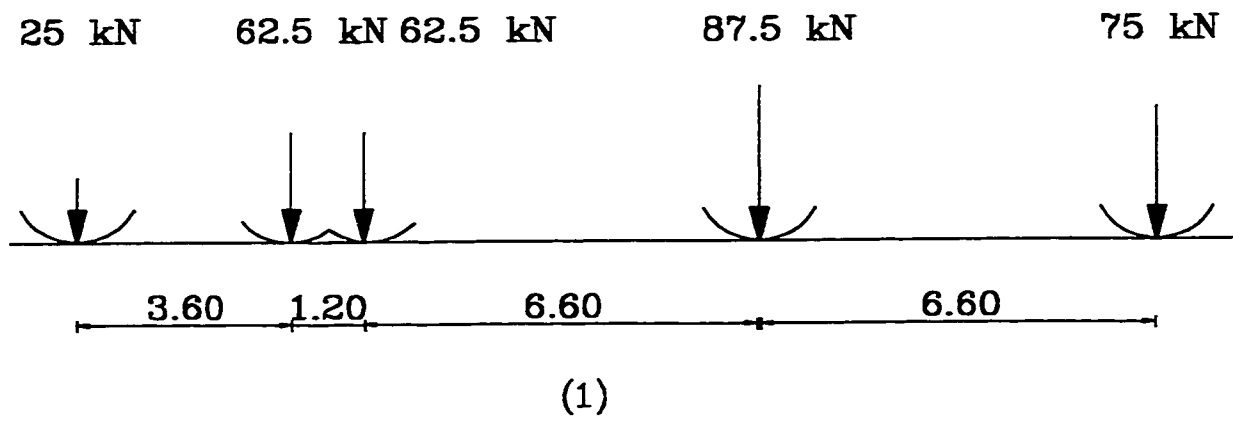
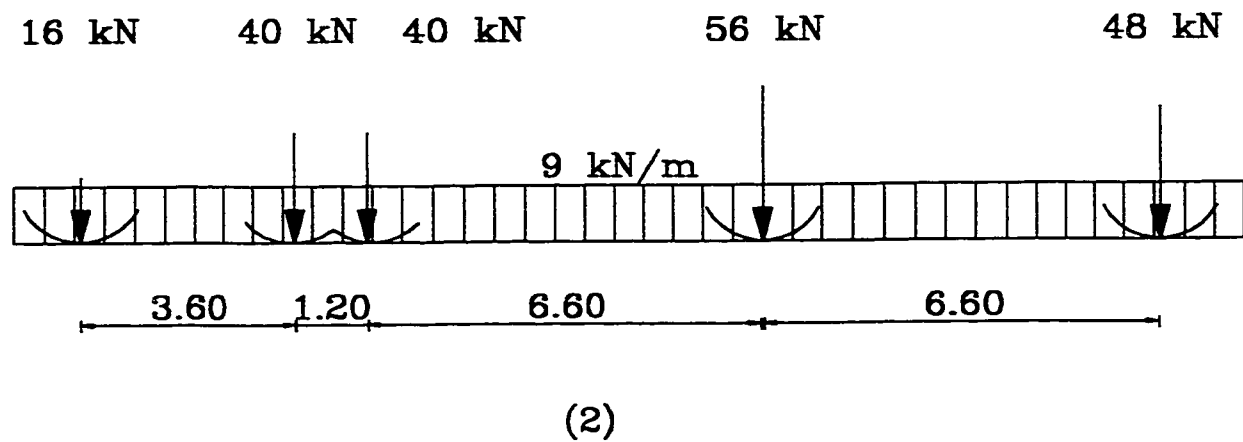
Figure 3. 4 Truck loads as specified in the CHBDC

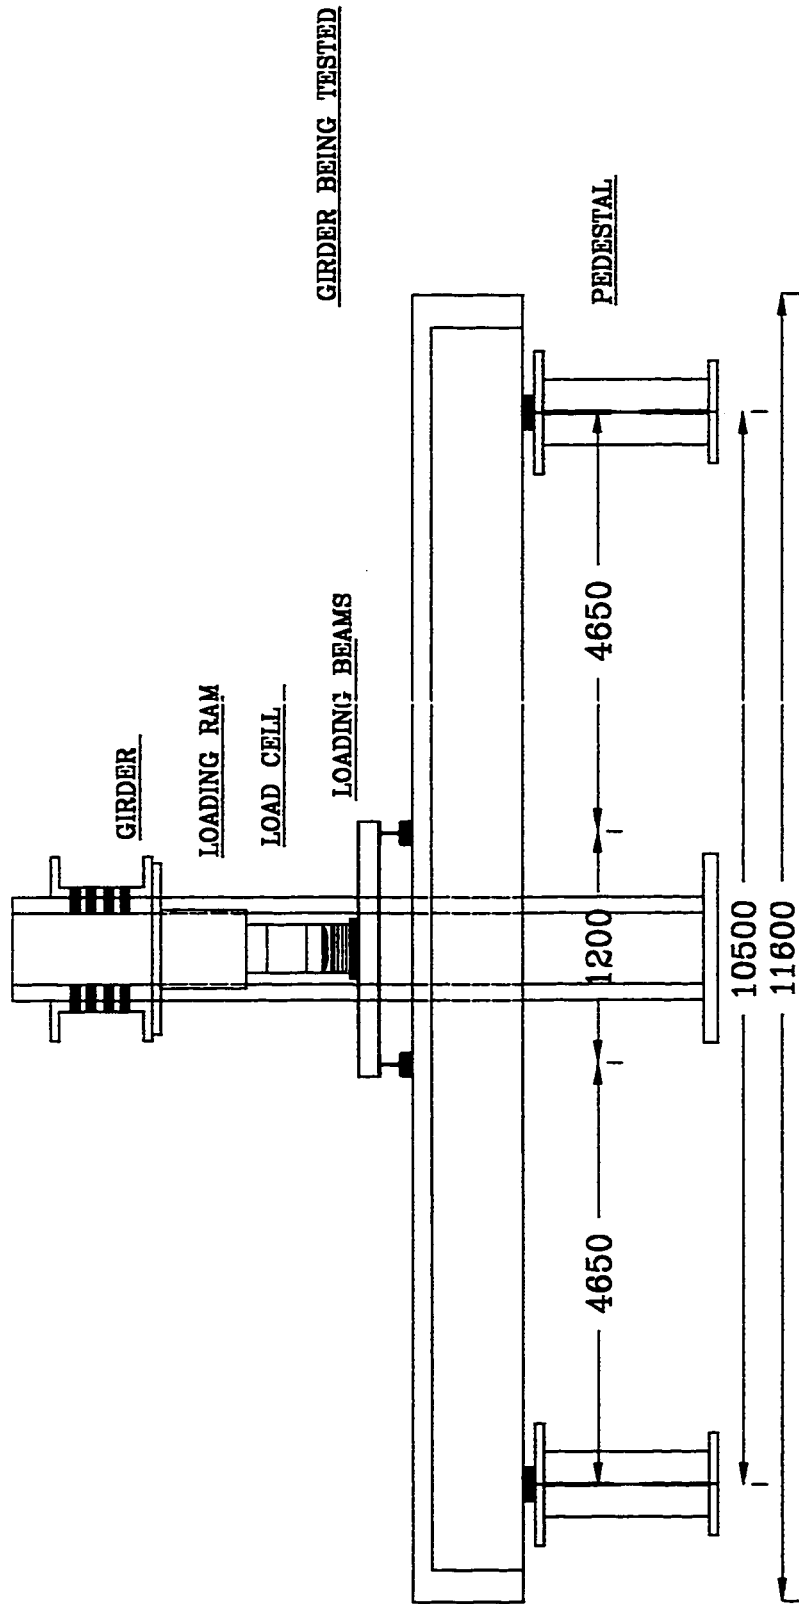
Figure 3.5 Arrangement of Test Frame

4 sets of neoprene pads were used, with one set at each loading point. Each set contained 4 pads 150×130×12.5 mm, which were stacked alternately with three 0.5 mm stainless steel plates. The steel plates ensure little lateral deformation of the stacks.

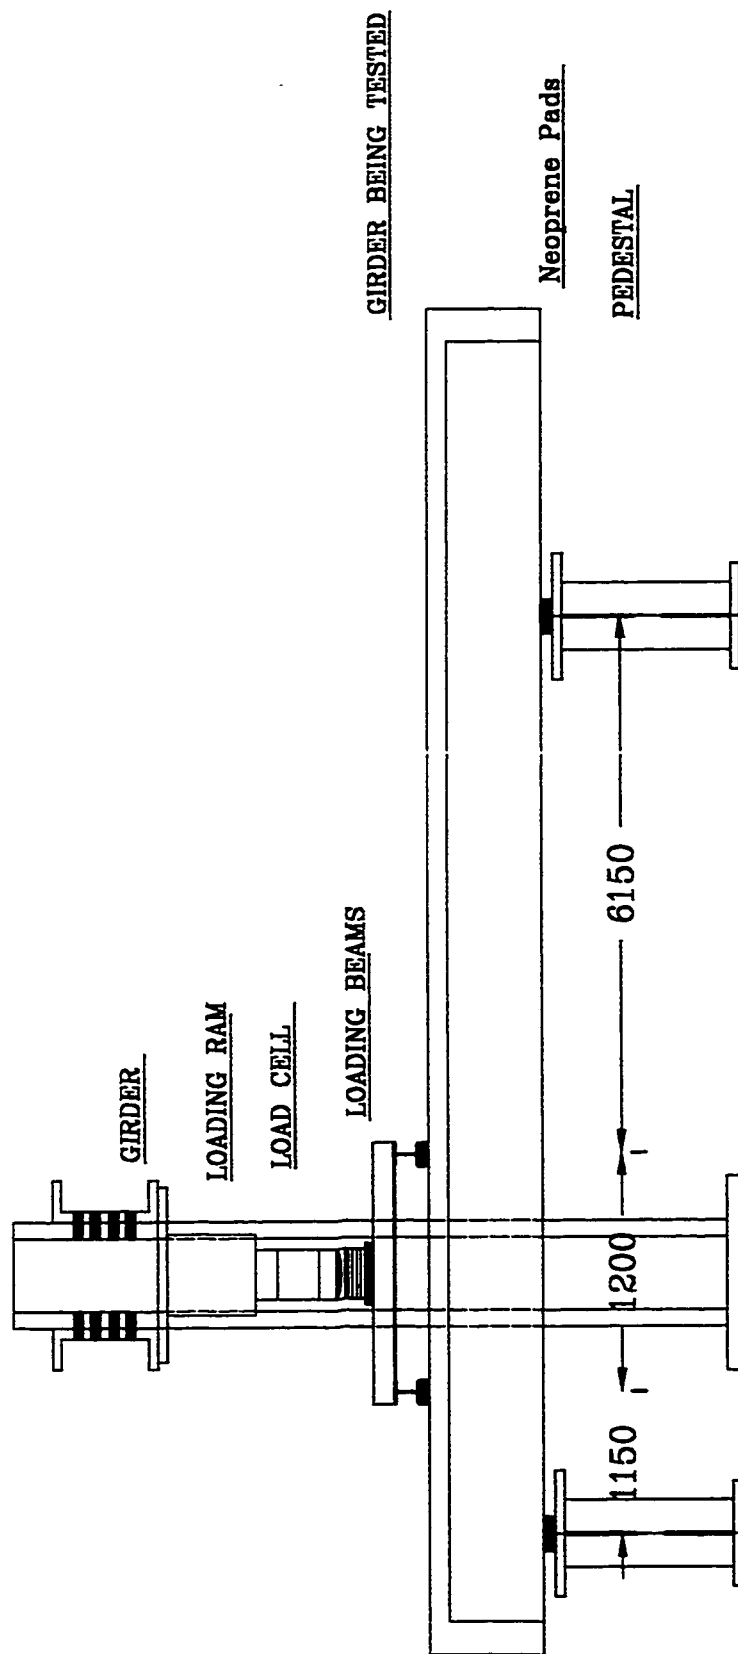
Figure 3.8 Arrangement of Shear Tests

Based on the compression field theory, the angle of the plane of failure in shear (θ) was calculated to be 36 degrees, providing a calculated shear span of about 760 mm. This span was increased to 1150 mm for the shear tests, while the total span under load was 8500 mm as shown in Figure 3.8. The same loading system was used as before with the

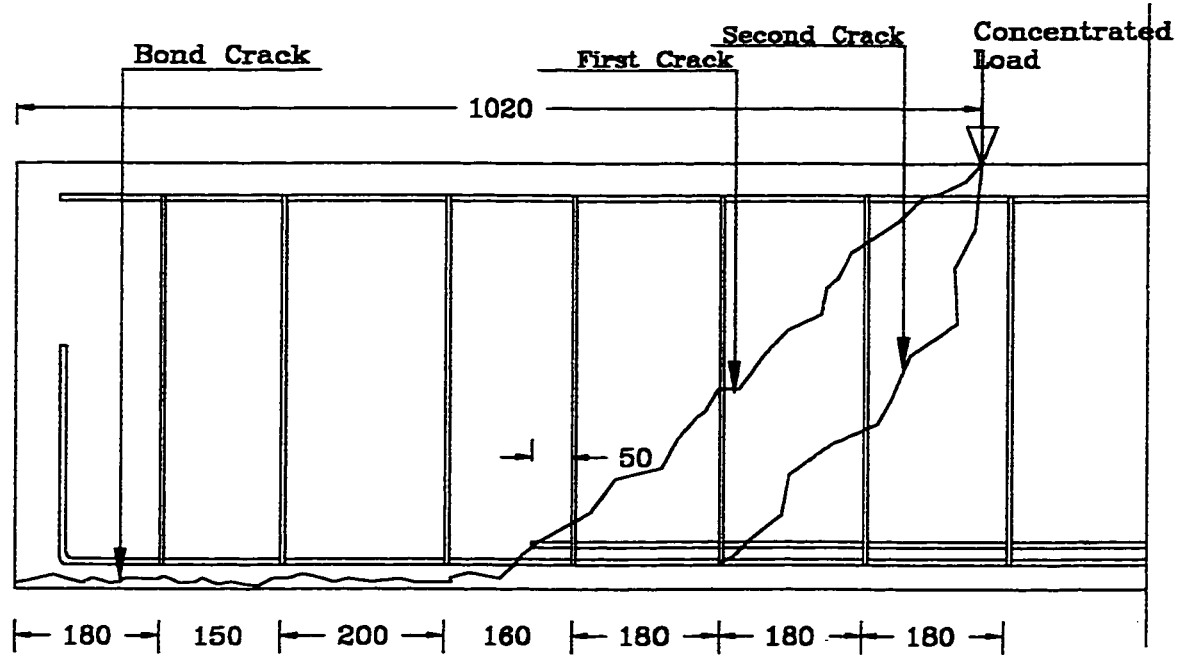
Figure 3.9 Crack Pattern at Failure after Shear

Showing Cracks in Relation to Tensile Reinforcement and Stirrups

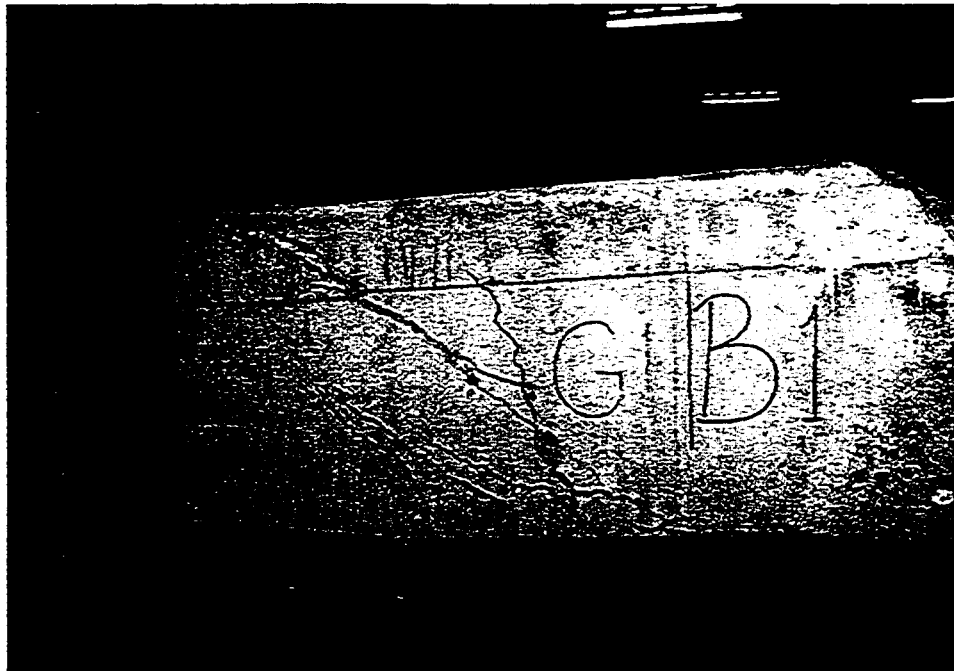
Figure 3.10 Cracks after Shear Test as in Figure 3.9

After tests 4 and 5 it became clear that the maximum capacity of the actuator produces a shear force less than the total shear capacity of the girders. The Enerpac jack with a capacity of 2000 kN was used to determine the actual shear resistance of the bridge girders. The testing arrangement was changed to accommodate this actuator. The second end of the first beam (considered to be in the “best” condition: same end as in test 5) was tested under the same configuration as tests 4 and 5. The beam was loaded directly to failure. Yield developed at 600 kN, and failure occurred at 645 kN. The reaction at the tested end was therefore 544 kN. At first, the cover spalled off at a previously marked bond crack. Two major cracks then developed in each web. The first crack began to propagate from the end of the bond crack, which was approximately at the end of the last curtailed reinforcing bar (Figure 3.9, 3.10). The second crack propagated from the bottom of the

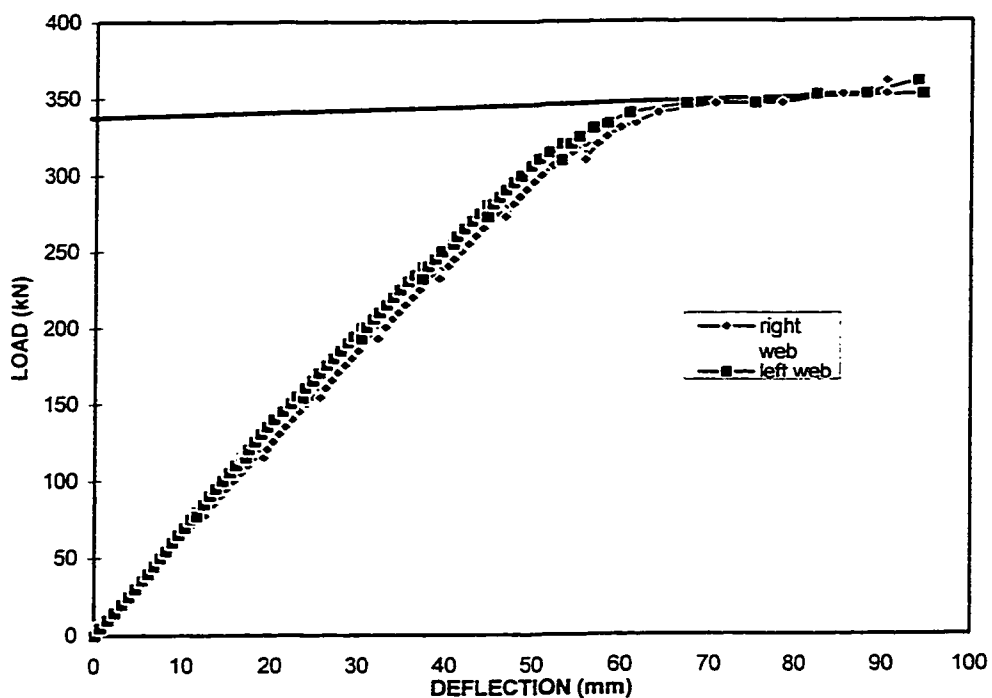
Figure 3.11 Deflection at Mid-span of the Good Beam; Flexural Test

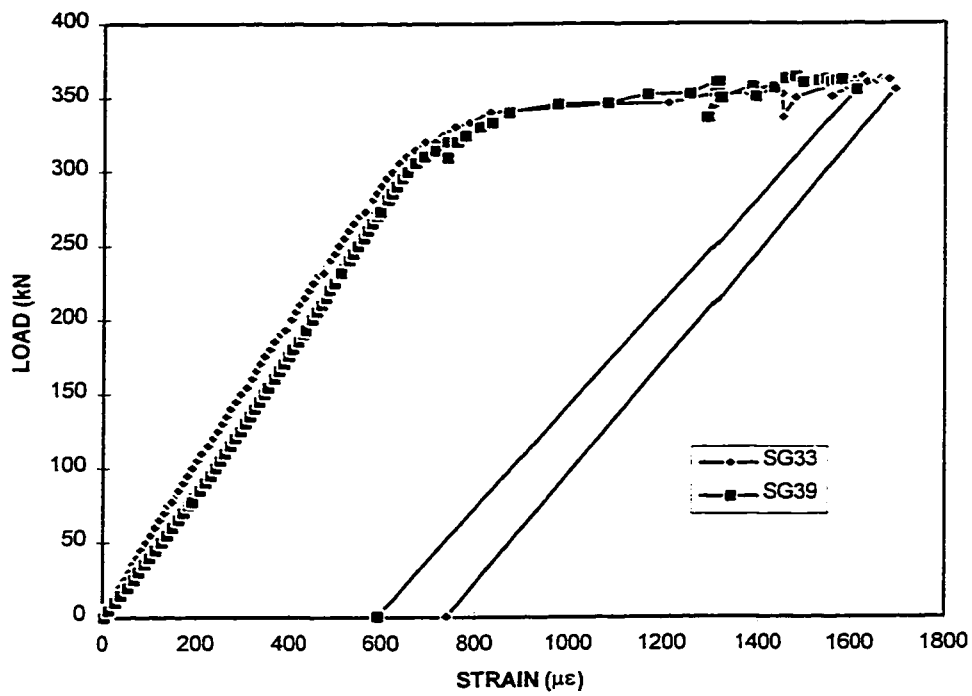
Figure 3.13 Strain measured in the Concrete on Top of the Good Beam; Flexural Test

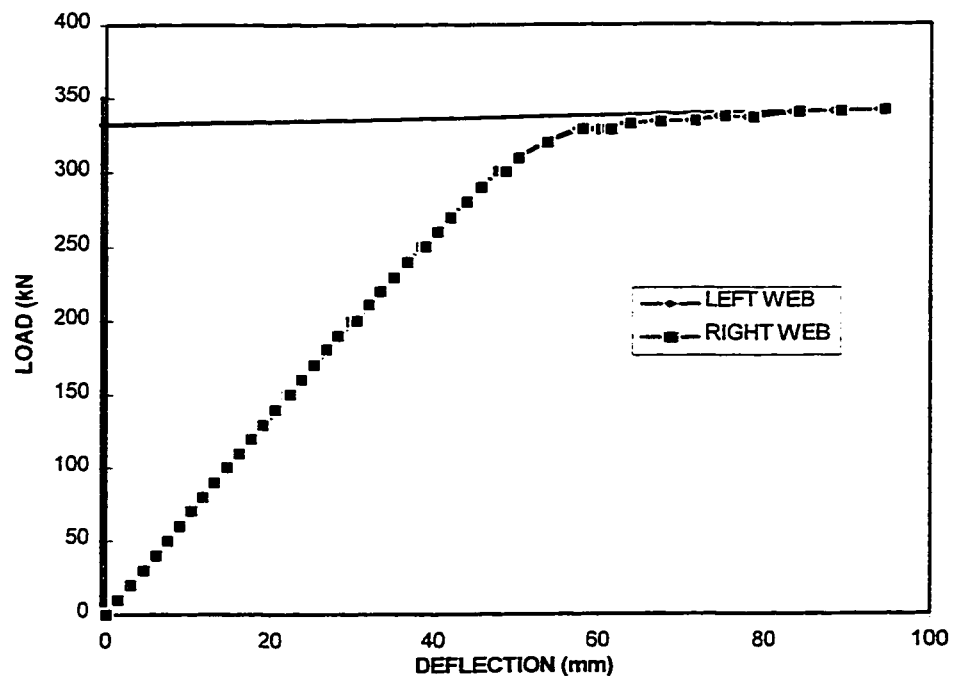
Figure 3.14 Deflection at Mid-span of Worst Beam; Flexural Test

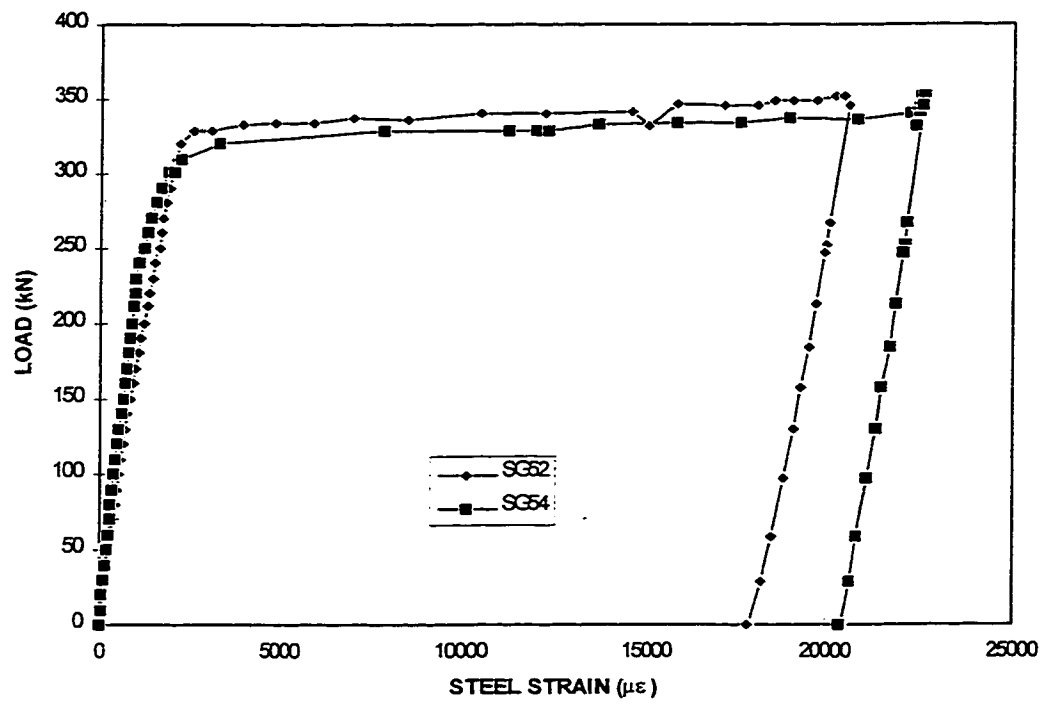
Figure 3.15 Strain Measured on the Bottom Steel of the Worst Beam; Flexural Test

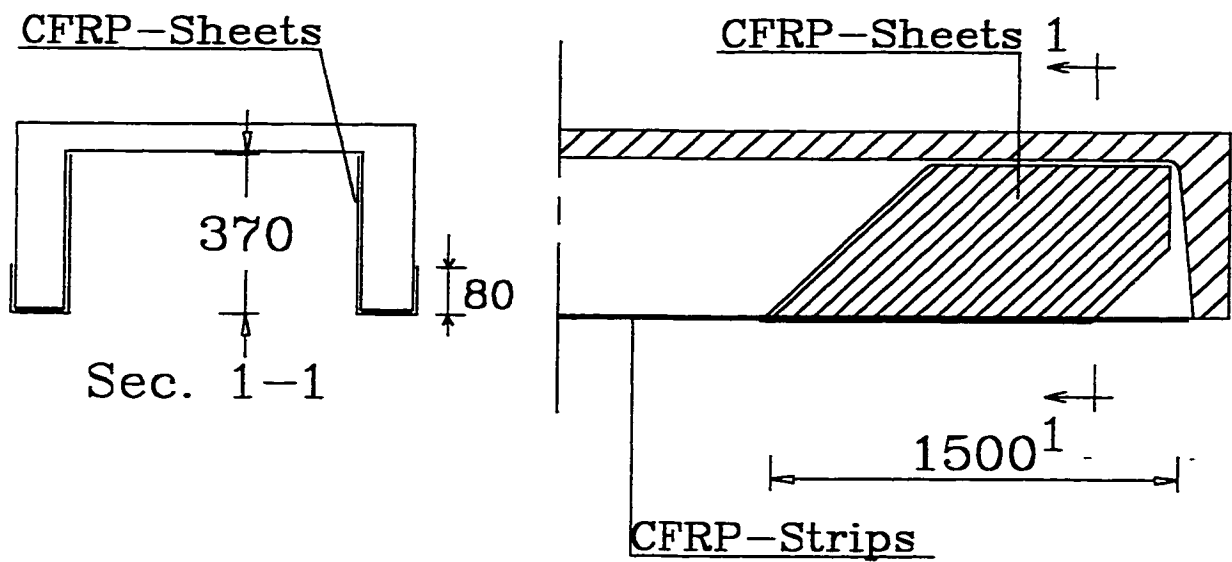
Figure 4. 1 Schematic Showing CFRP-Sheets/ Strips on the Beam (Dimensions in mm)

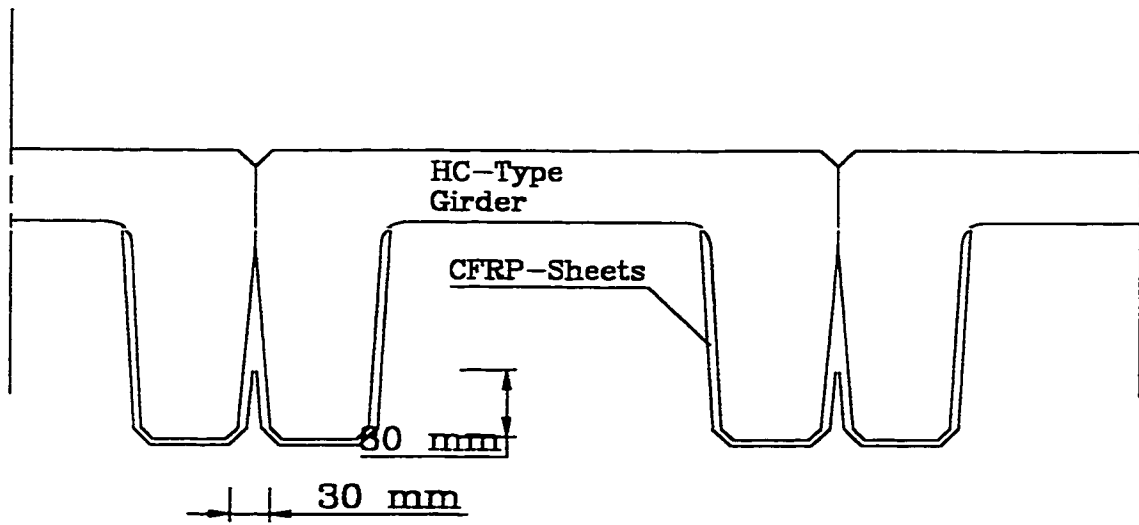
Figure 4. 3 The Webs of the Beams in The Bridge Layout

The CFRP-sheets were mounted on the internal side of the webs of the beams on 45° for a length of 1.50 m to act like external shear reinforcement. The layout of the bridge is such that the beams are near each other without any space left between them. It is only possible to wrap the sheets from the inside, coming 80 mm from the outside of each web as shown in Figure 4.3. Based on the known properties of the CFRP-sheets (strength and cross-sectional area), the new shear capacity was calculated. The equations of the CSA-23 were used treating the CFRP-sheets as bent bars.

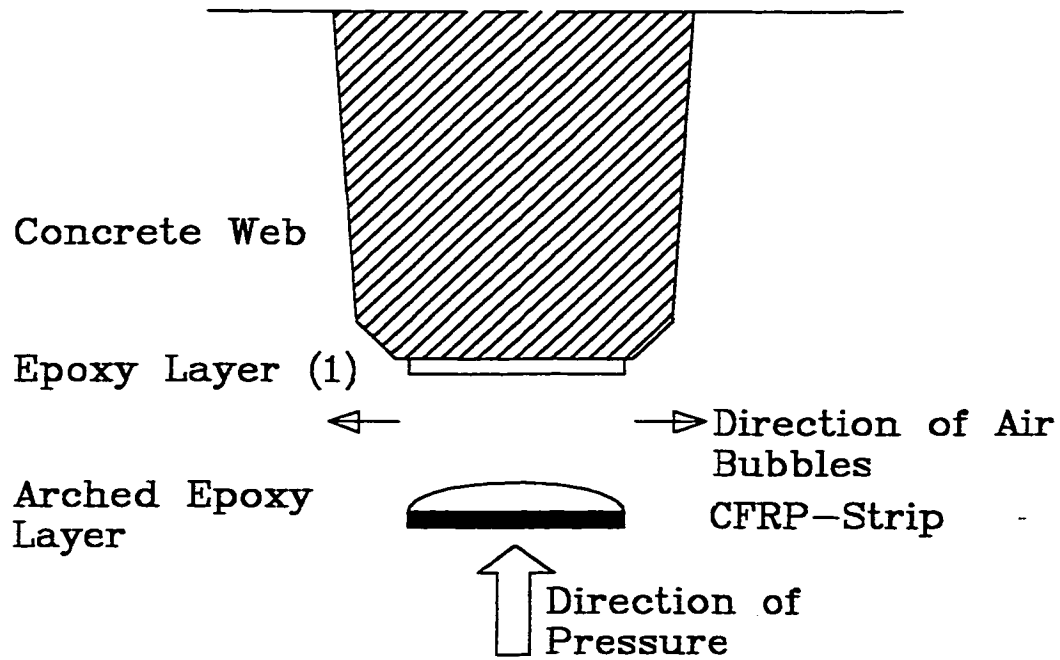
Figure 4. 4 Schematic Showing Arched Shape of Epoxy on CFRP-Strip
