**Rehabilitation of HC-Type Bridge Girders Using CFRP-Sheets/ Strips or
External Post-Tensioning**

Amr H. Riad

A THESIS

DEPARTMENT OF CIVIL ENGINEERING

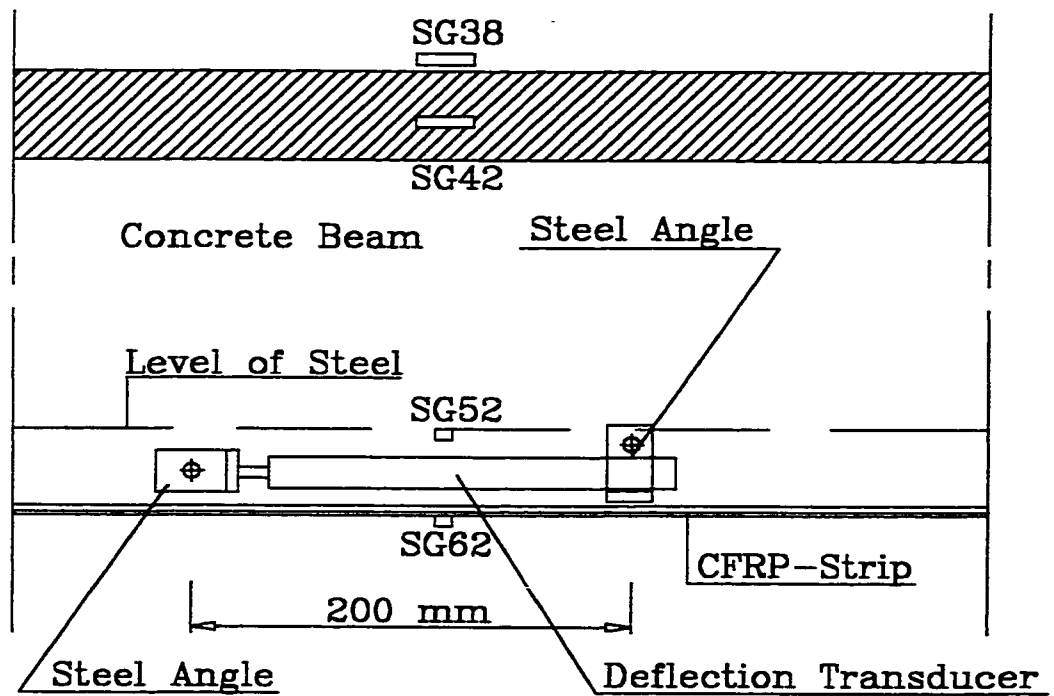
Figure 4. 9 Strain Profile in Beam under Test

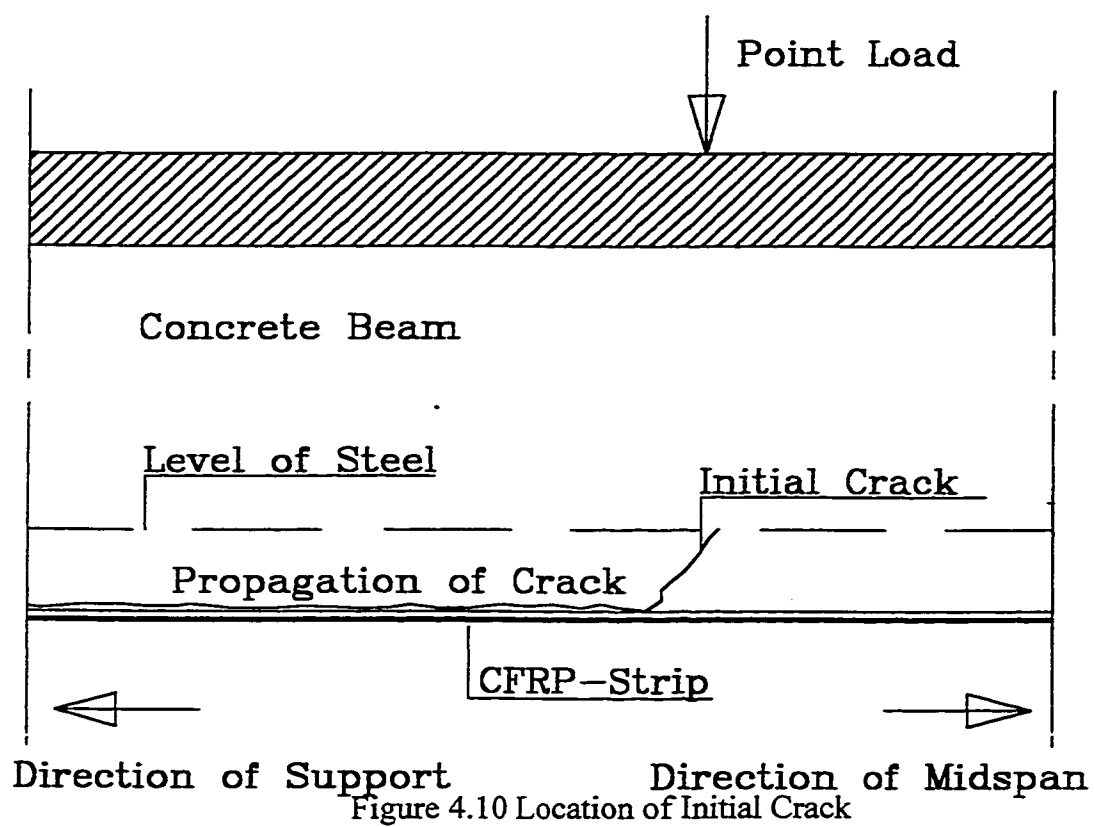
Figure 4.11 Critical Crack in Test

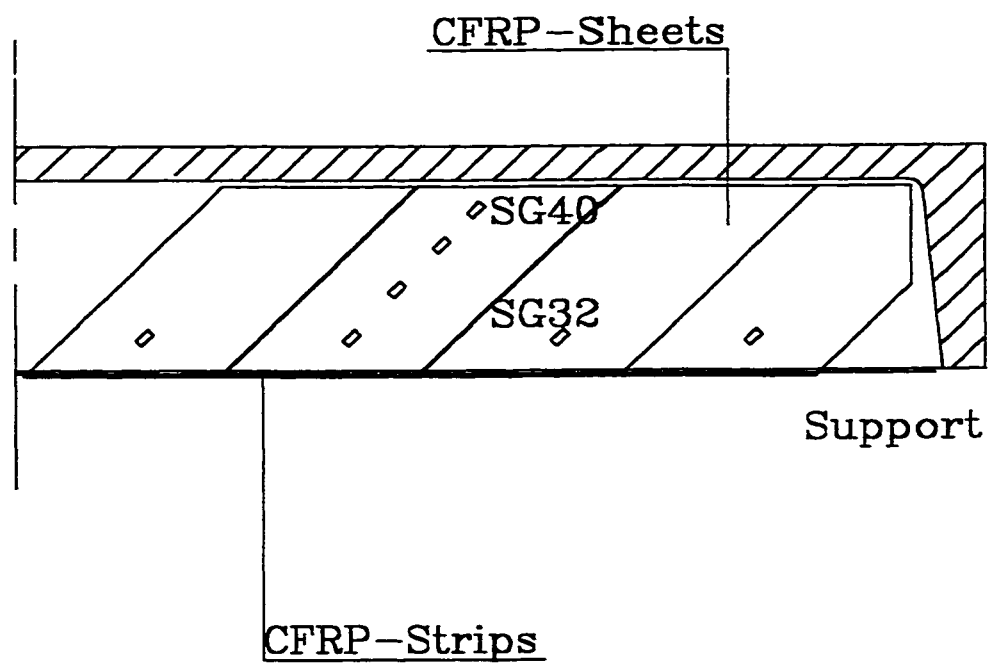
Figure 4.12 Orientation of Strain Gauges on the CFRP-sheets (Shear Test)

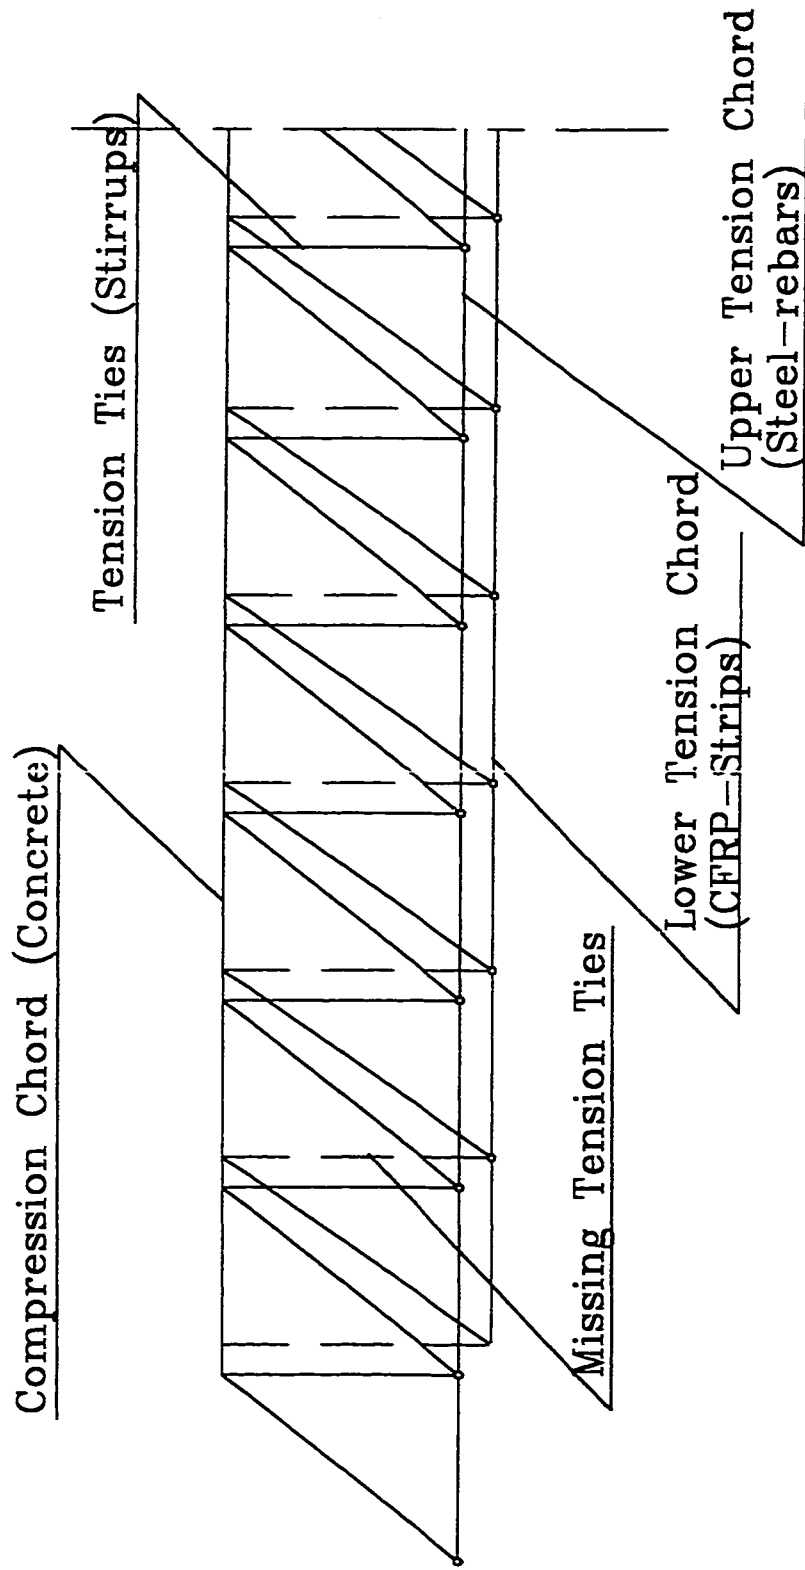
Figure 4.13 Truss Model for Beam

With the truss model, it can be shown that under the level of reinforcing bars the section becomes unsafe (plain concrete only) at a concentrated load of 290 kN. As was noticed in the tests the crack began to propagate at a load of 260 kN. Allowing for the approximations in the calculations, the theory therefore seems to give a reasonable explanation of the initiation of failure.

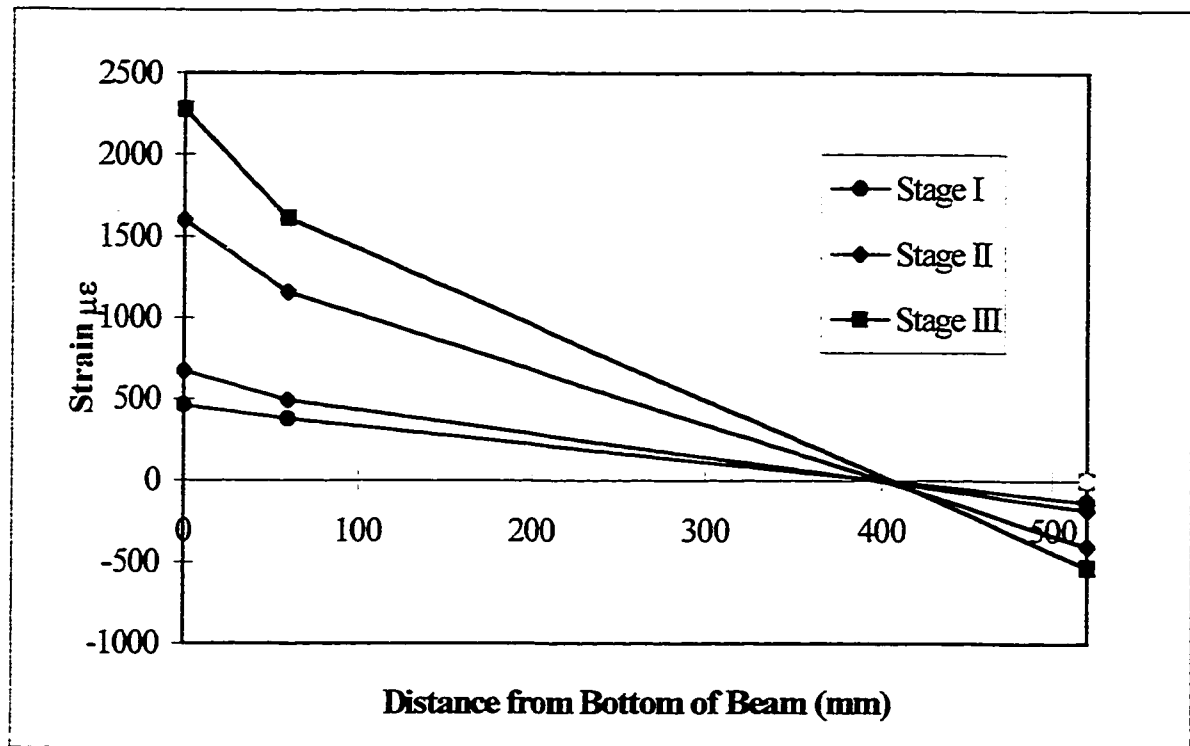
Figure 4.14 Strain Profile in Stages I, II and III for Beam 1

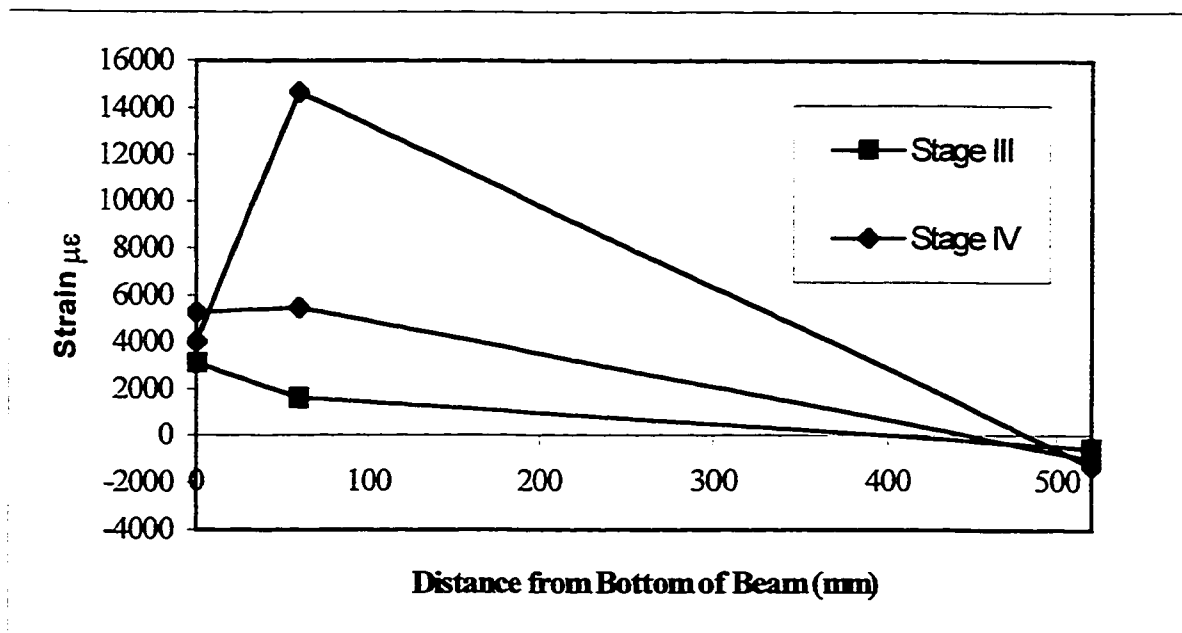
Figure 4.15 Strain Profile in Stages III, V for Beam 1

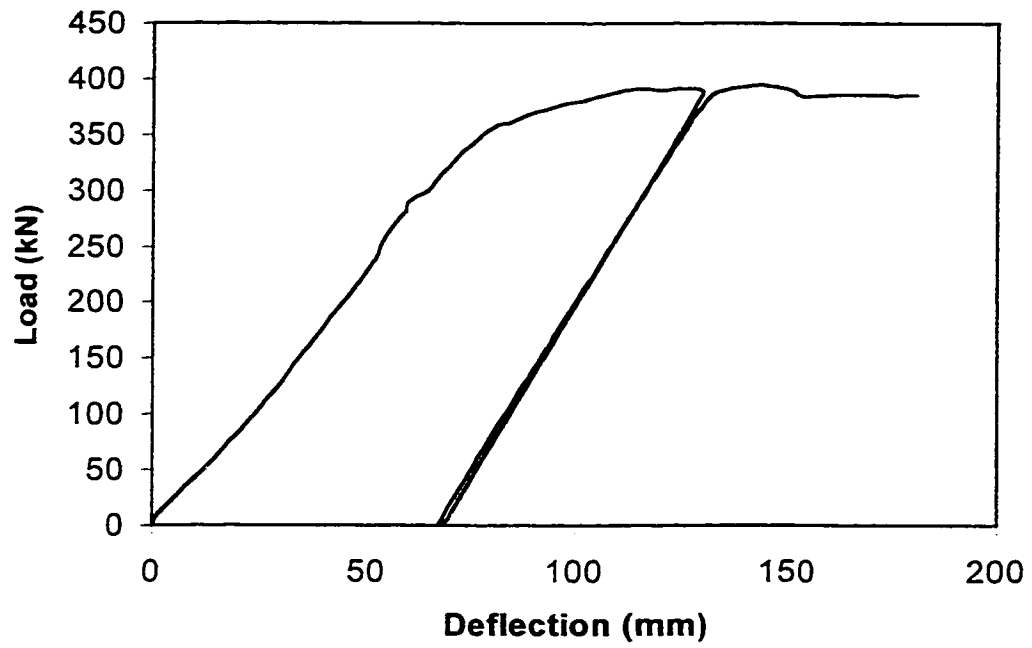
Figure 4.18 Vertical Deflection of Beam 1

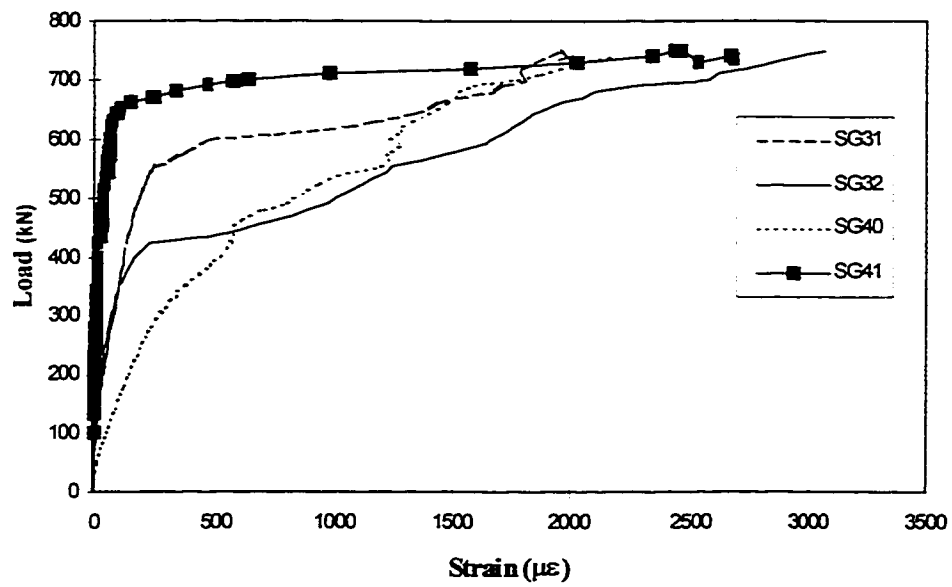
Figure 4.19 Strain in Shear Test

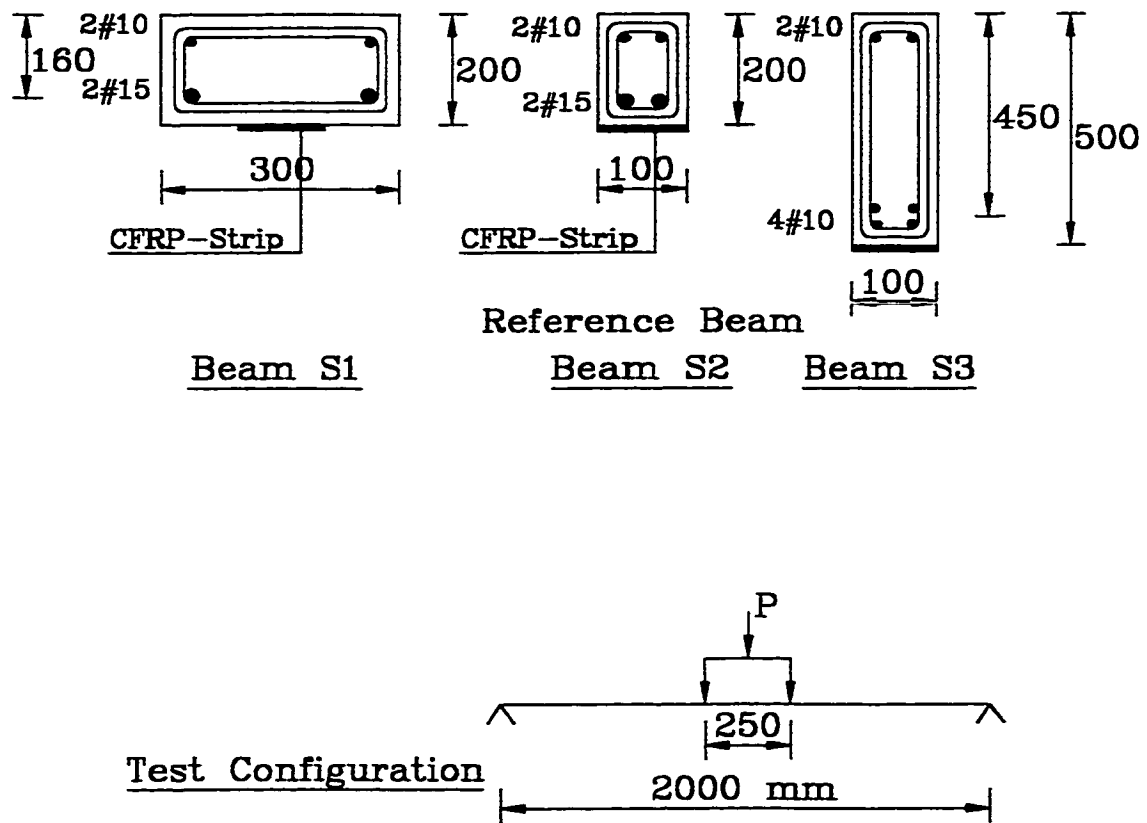
Figure 4.20 Cross-sections of Beams S1, S2 and S3 and Testing Configuration

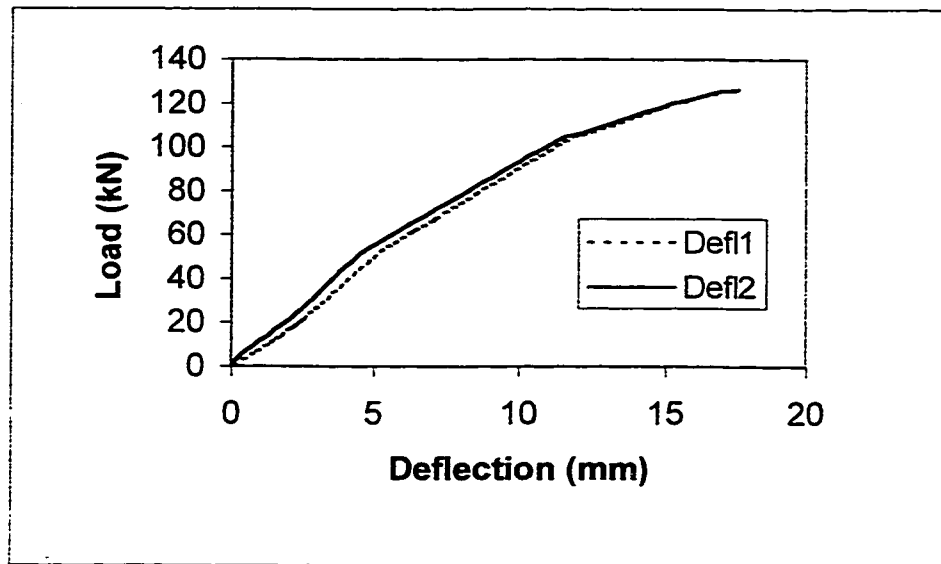
Figure 4.21 Load vs. Deflection for beam S1

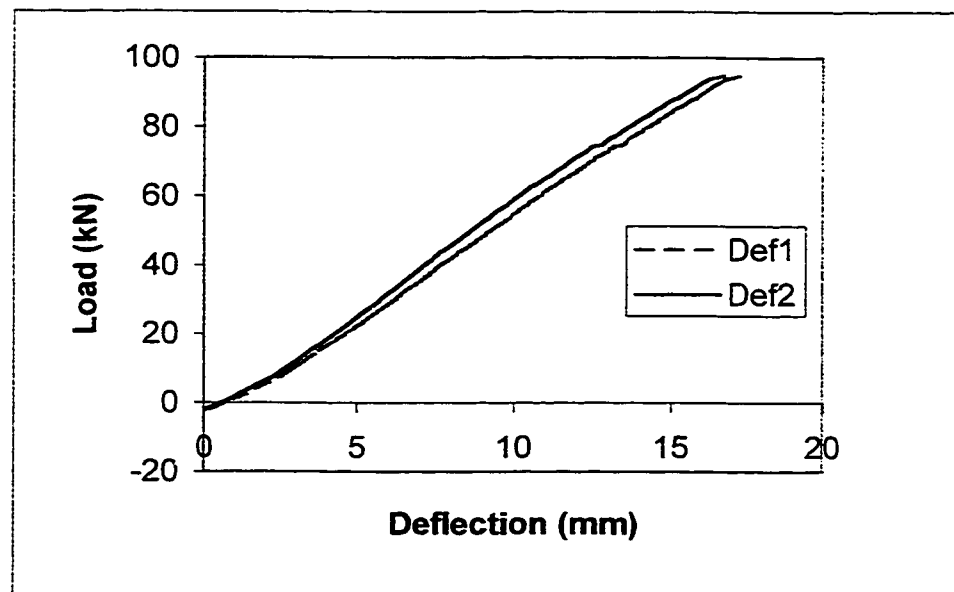
Figure 4.22 Load vs. Deflection for beam S2

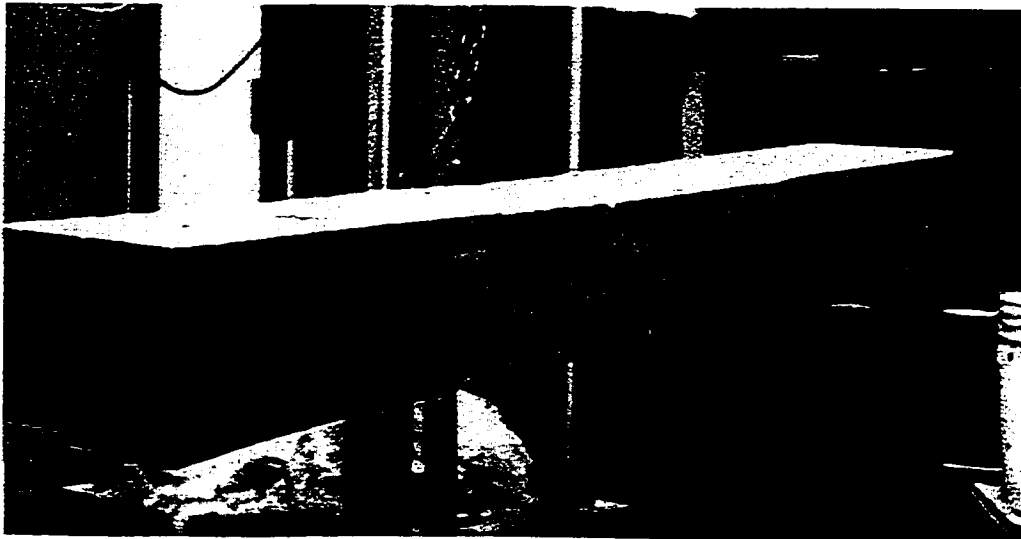
Figure 4.24 Failure of CFRP-strips in beam S1

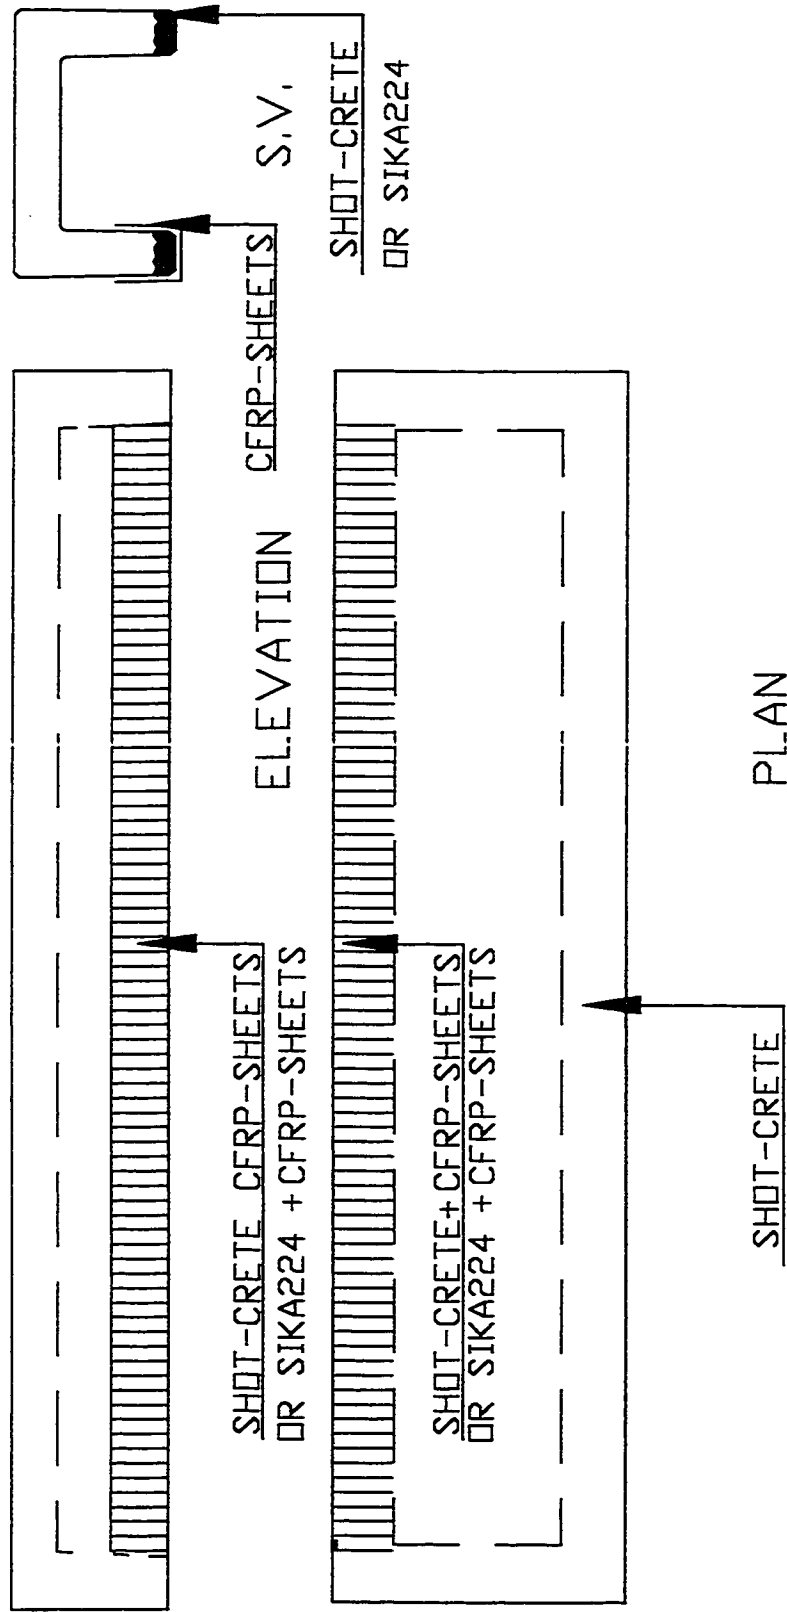
Figure 4.27 Layout of CFRP-sheets in Cyclic Testing

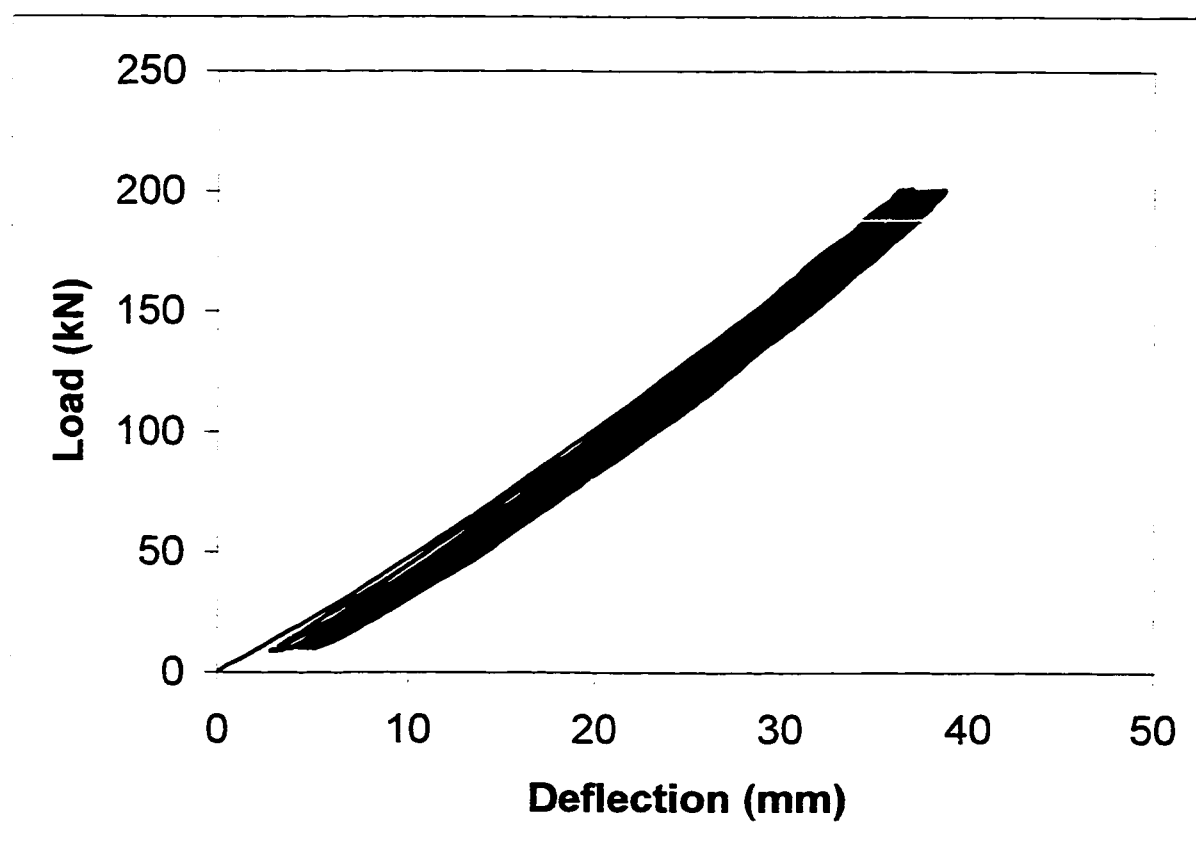
Figure 4.28 Vertical Deflection in Cyclic Test

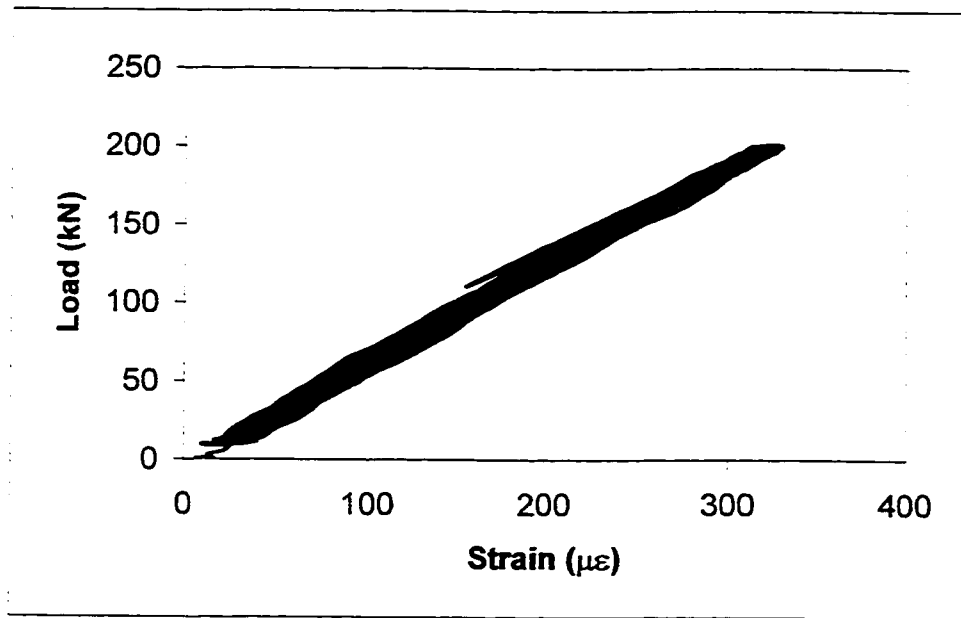
Figure 4.29 Concrete Strain in Cyclic Test

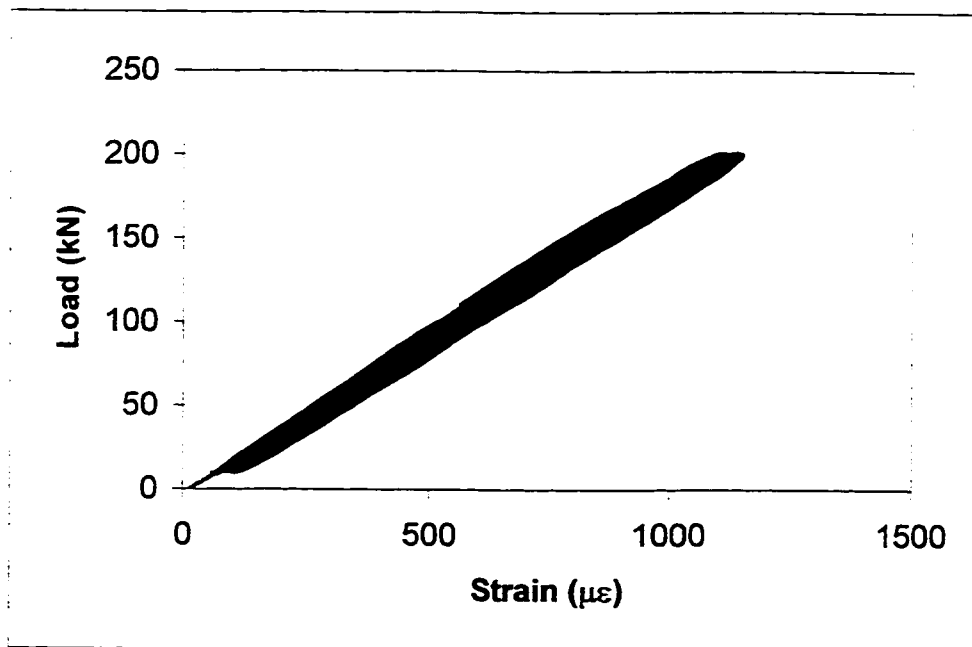
Figure 4.30 Steel Strain in Cyclic Test

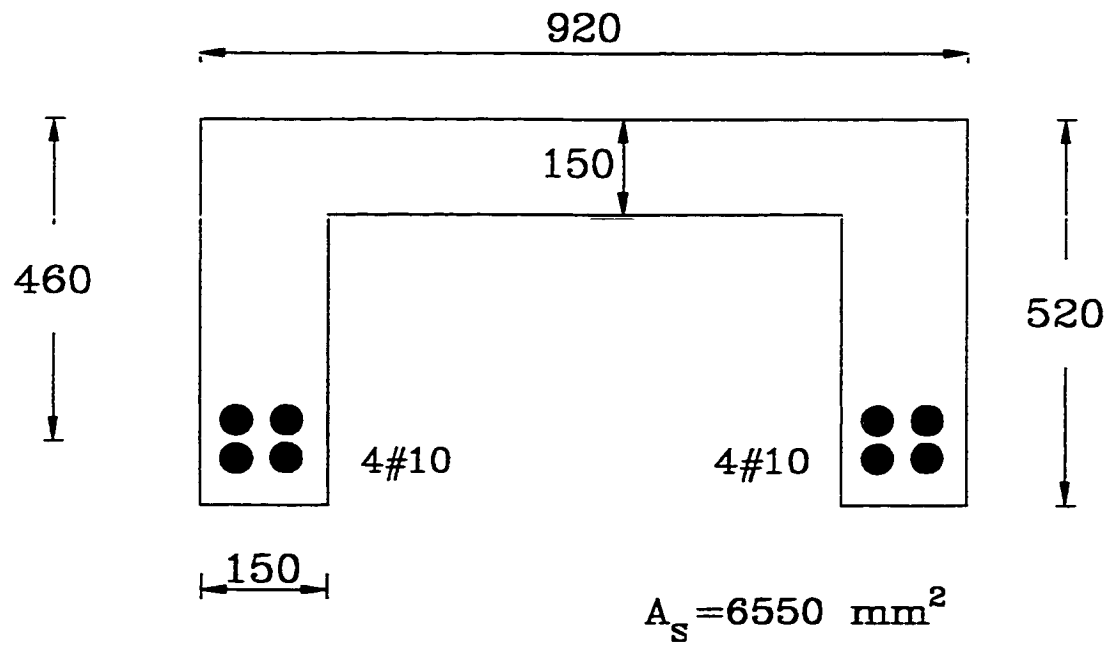
Figure 5.1 The Idealized Cross-section of the Beam

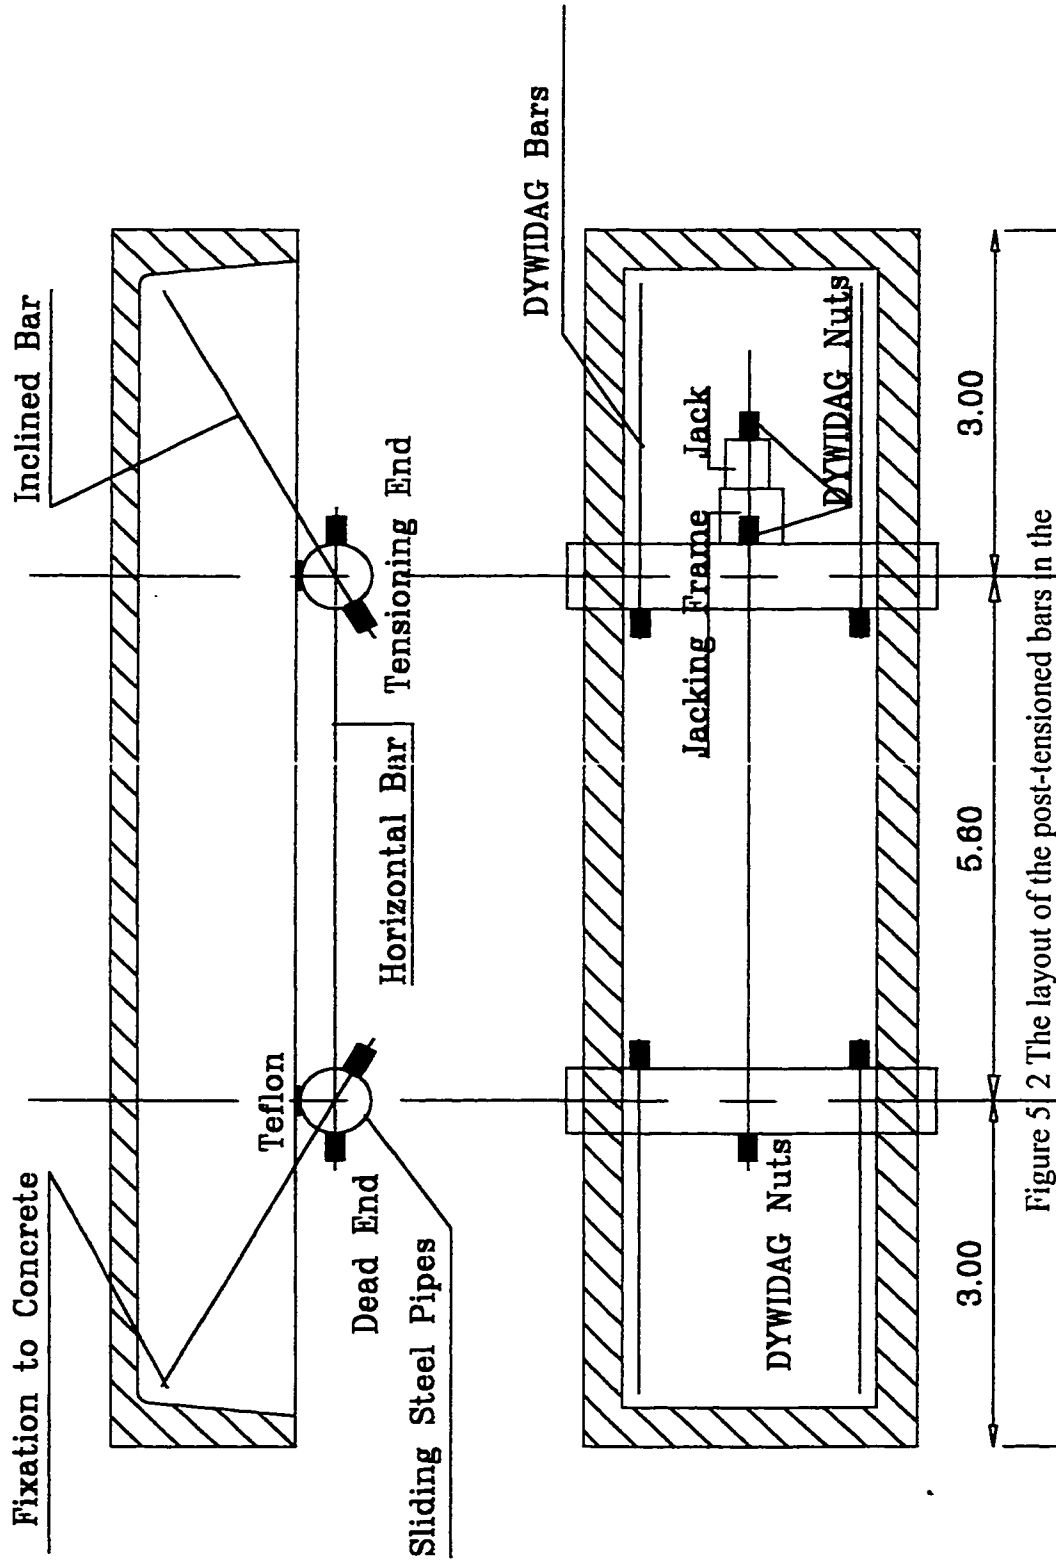
Figure 5-2 The layout of the post-tensioned bars in the

The idea of the post-tensioning was to jack the whole system in one operation. This was done by connecting the four inclined bars with the straight bar by a steel hollow circular section. The circular shape was chosen to make it easier to drill holes at different angles. Teflon plates greased with vaseline were put between the circular sections and the soffits of the beams. As one end of the horizontal bar is stressed, the horizontal bar applies compression on the two circular pipes. The circular pipes move towards the centre of the beam and can slide along the soffits of the beam due to the existence of the teflon plates.

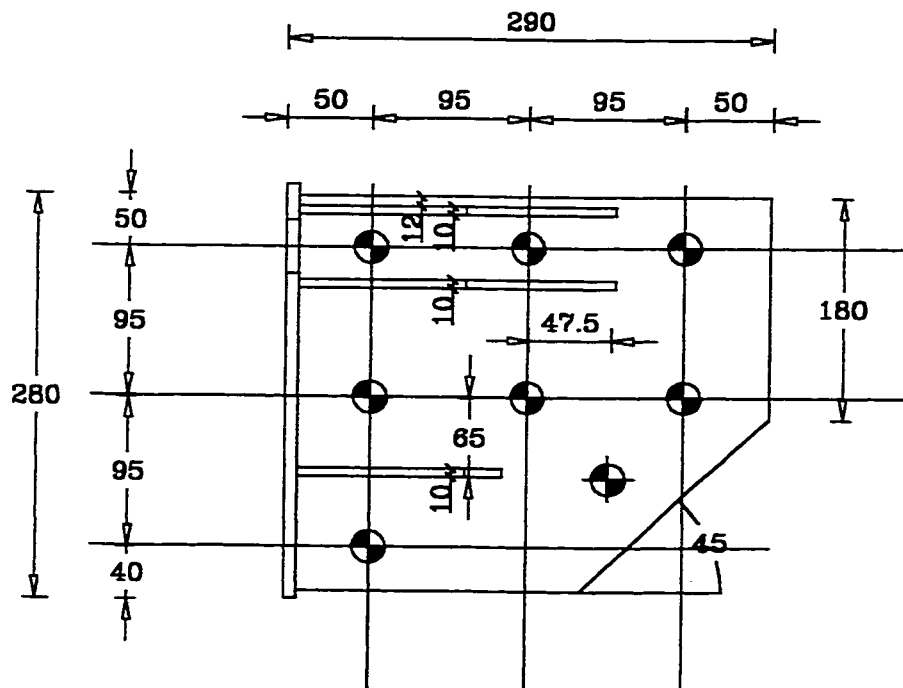
Figure 5. 4 The Dimensions of the Steel Connection

The idea of using a steel connection fixing the inclined bars to the concrete webs was raised after determining that it was not possible to fix the bars to the diaphragms of the beams directly and obtain sufficient resistance for the required post-tensioning force. The diaphragms were, as previously noted, damaged and weakly reinforced. The steel connection (Figure 5.4, and Figure 5.5) was designed to resist a force of 200 kN in service conditions. The connection is an eccentric connection, which resists direct shear, torsion and moment, as seen in the drawing. The places of the stirrups and the reinforcing bars, as well as the fillets on the inside of the beams were taken into consideration in the design (Figure 5.6). The connection was designed to be light weight with the least number of anchor bolts to be safe. The anchor bolts were high strength UCAN-fasteners with 12 mm diameter. The properties of the bolts are listed in Table 5.1.

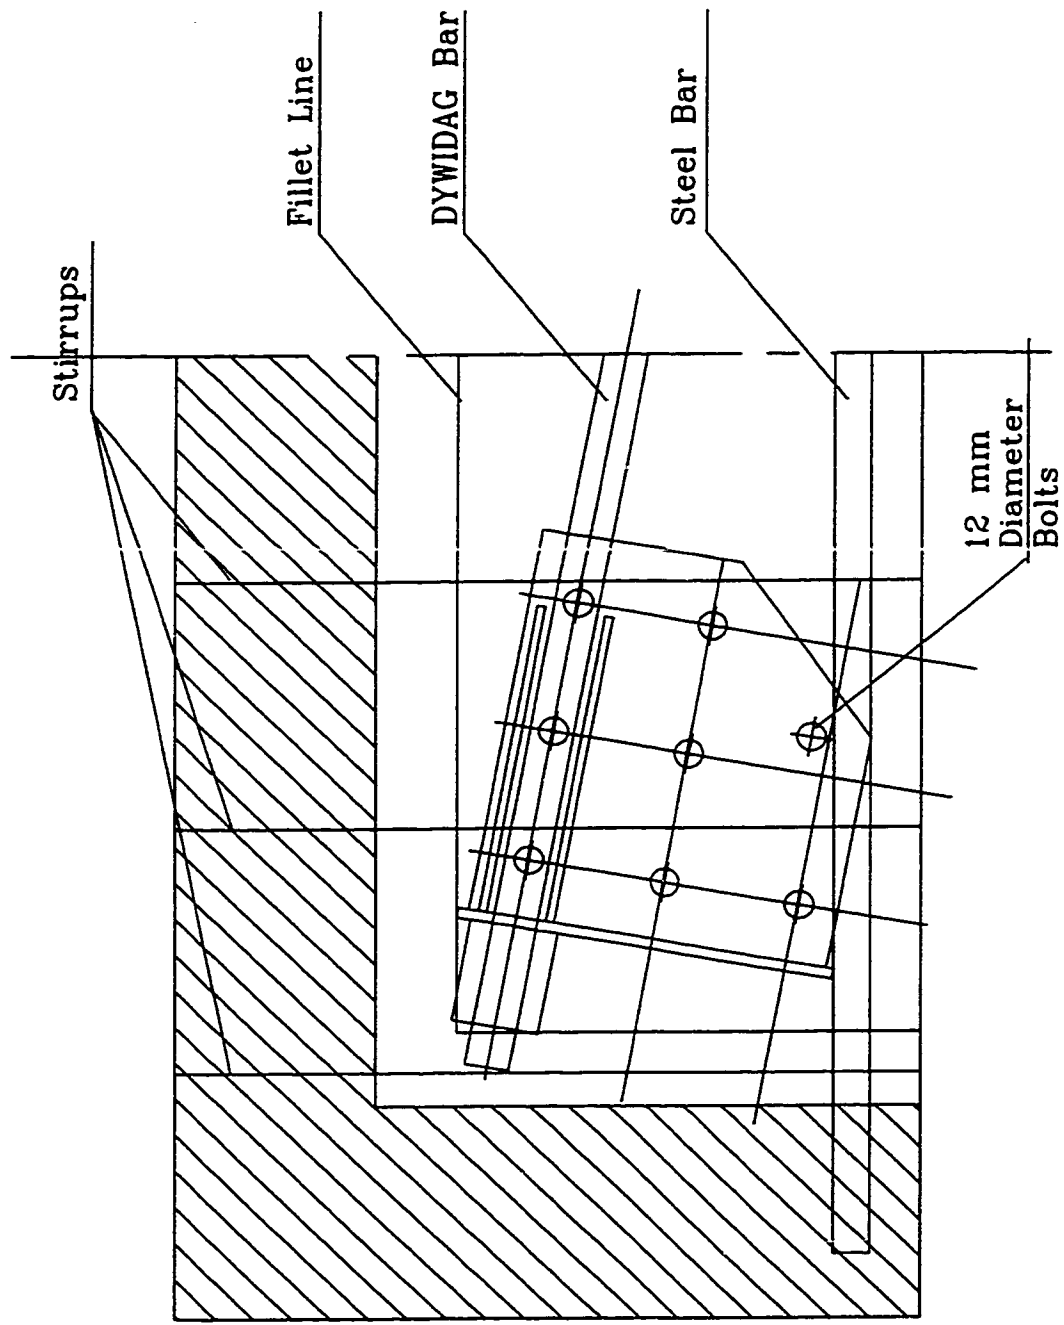
Figure 5.6 The location of the connection on the webs of the beams

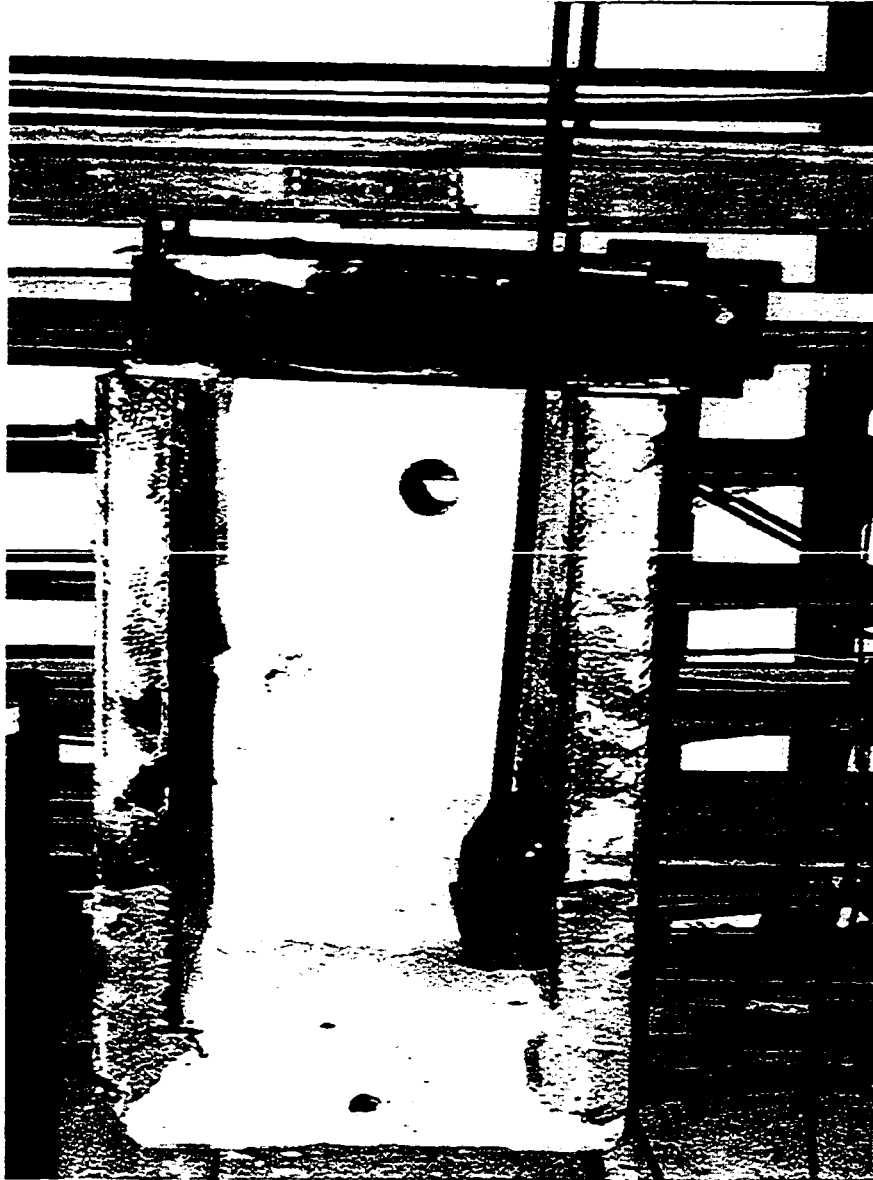
Figure 5. 7 The Pull-out Test on a Trial Connection

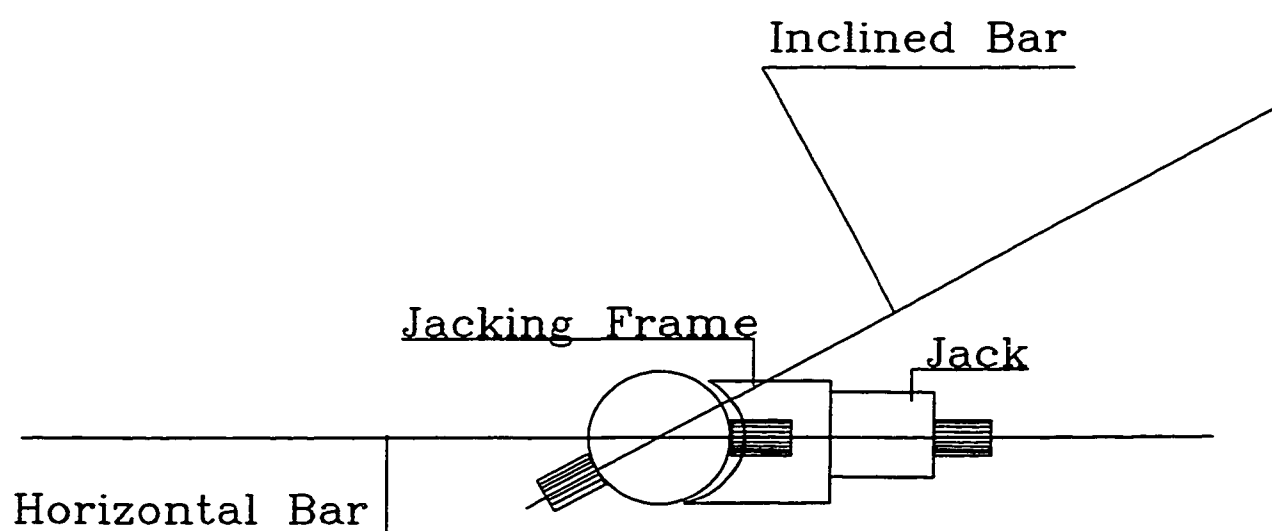
Figure 5. 9 The Jacking System Used in Post-Tensioning

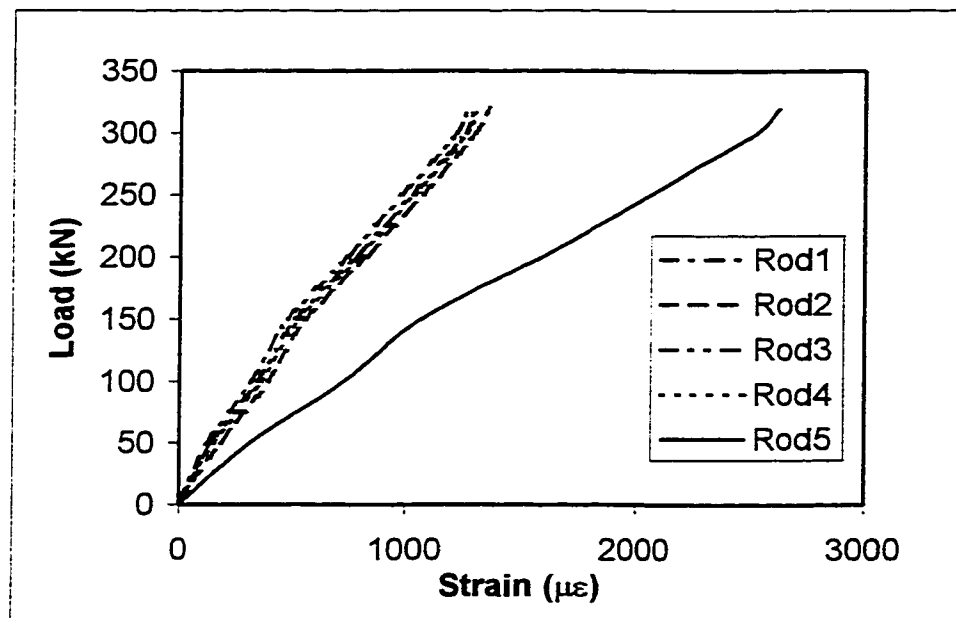
Figure 5. 10 The Strain in the Bars During Post-tensioning (First Beam)

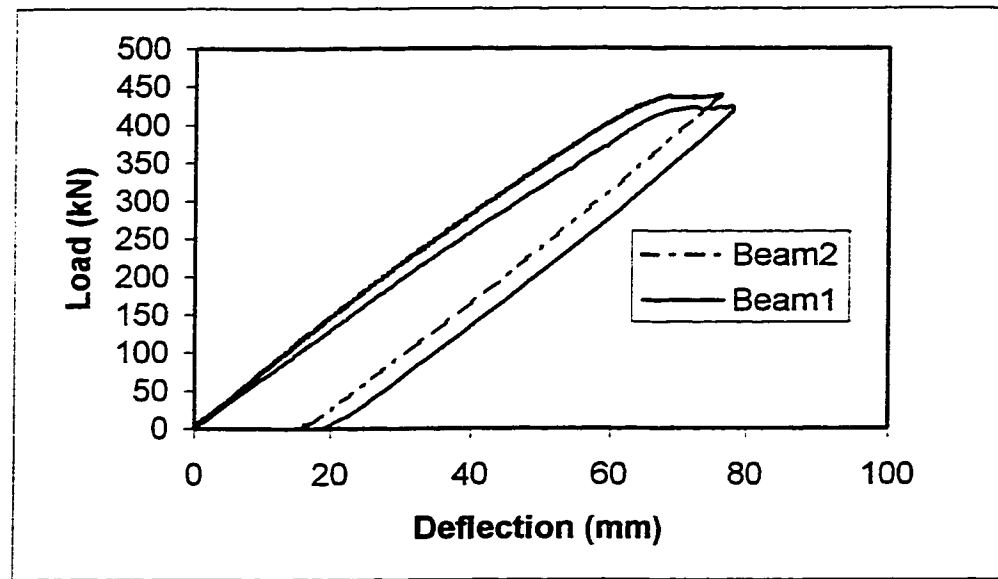
Figure 5. 13 The Vertical Deflection in Both Beams

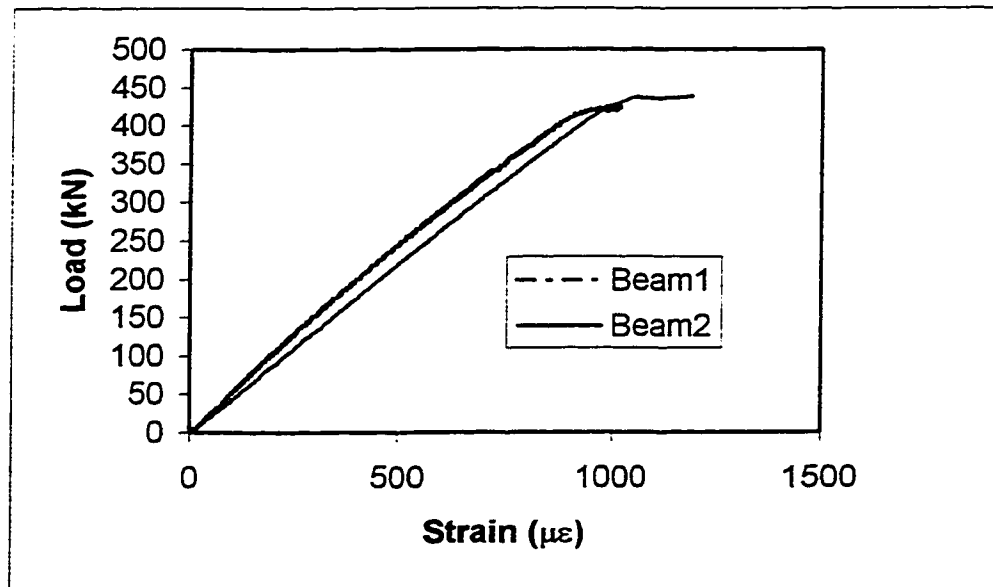
Figure 5. 14 The Concrete Strain in Both Beams

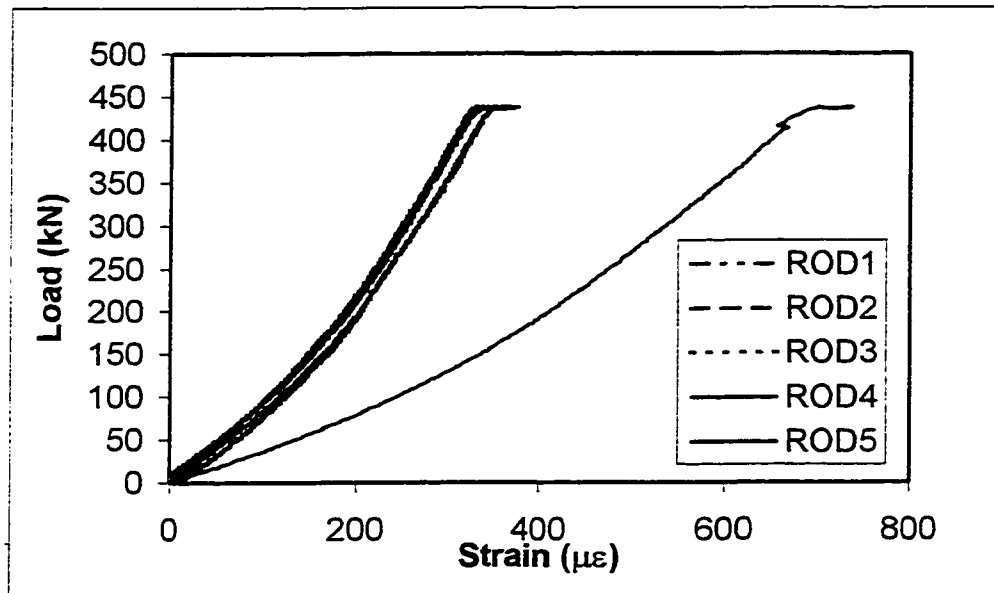
Figure 5. 15 The Strain in the Post-tensioned Steel During Testing of First Beam

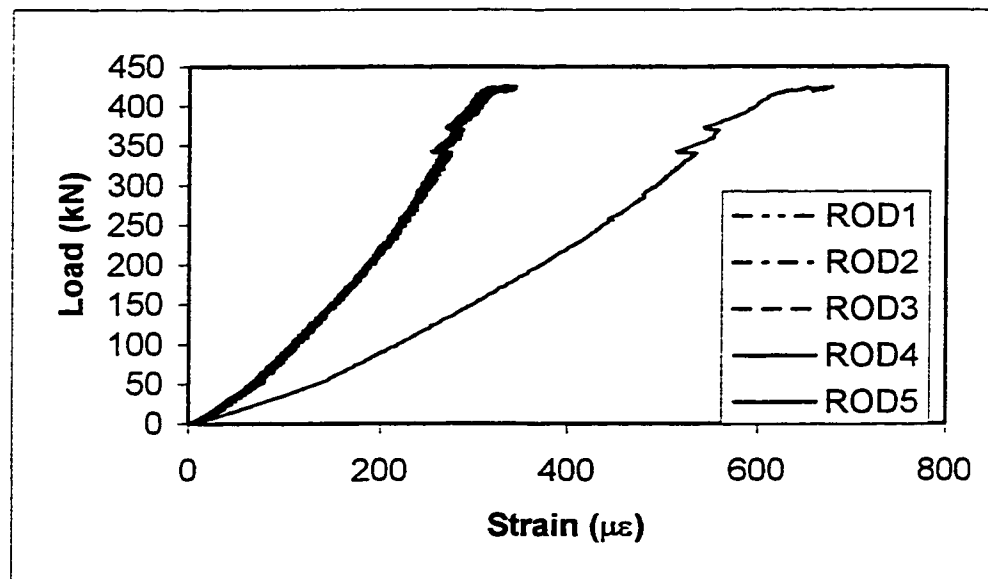
Figure 5. 16 The Strain in the Post-Tensioned Steel During Testing of Second Beam

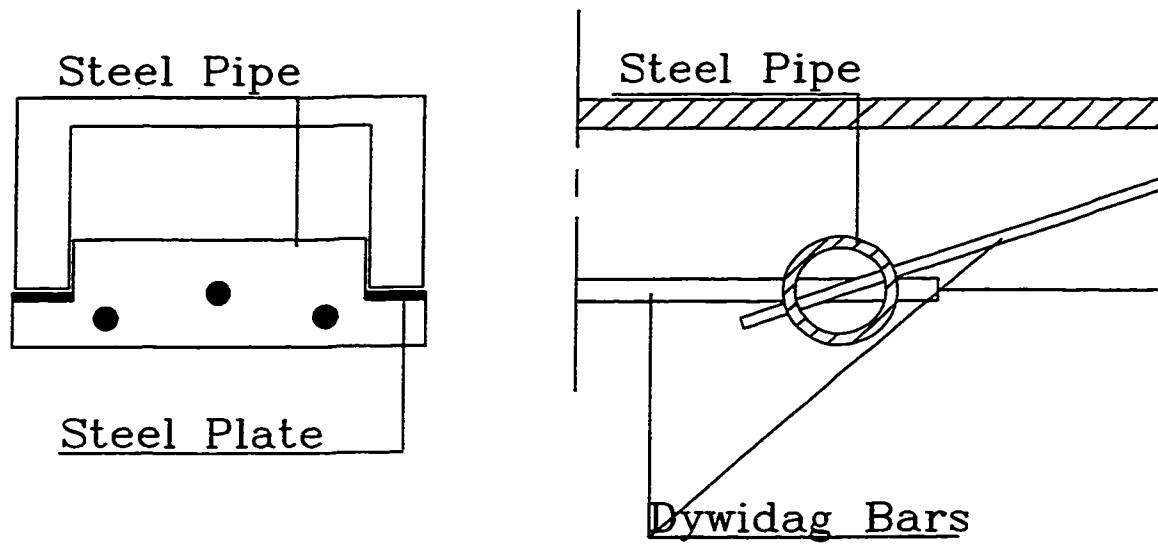
Figure 6. 1 Half- Imbedded Circular Pipe Supported by Flat Plate on Webs
