**Rehabilitation of HC-Type Bridge Girders Using CFRP-Sheets/ Strips or
External Post-Tensioning**

Amr H. Riad

A THESIS

DEPARTMENT OF CIVIL ENGINEERING

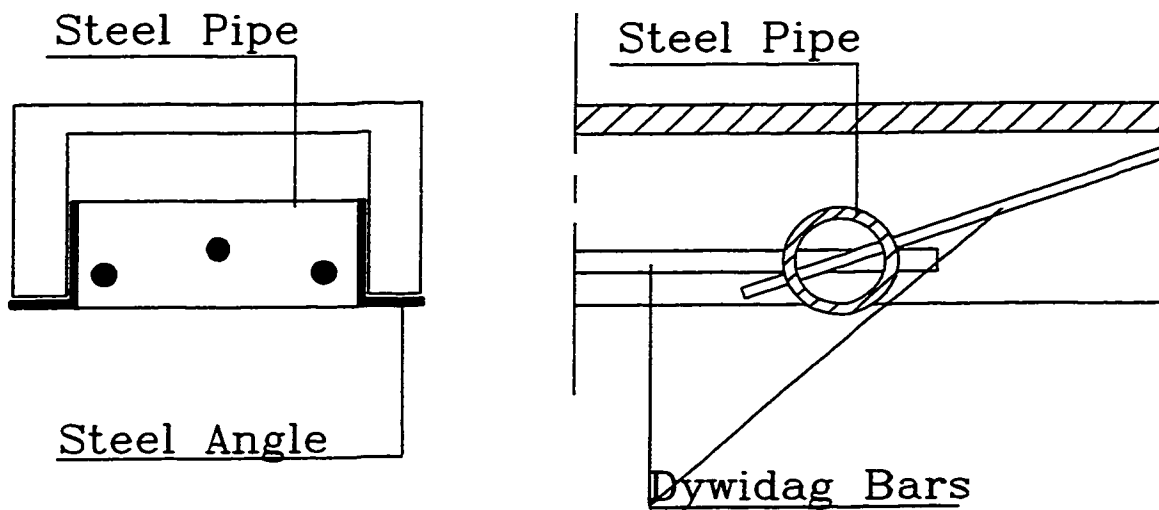
Figure 6. 2 Fully- Imbedded Circular Pipes Supported by Welded Steel Angle
