Conserving Calgary's Cultural Landscapes: Preservation, Restoration and Adaptive Reuse

Paper presented at the Parks 2008 40th Anniversary Conference - *Canadian Parks for Tomorrow*, May 13
Michelle Reid, BLArch, MEDes, CSLA

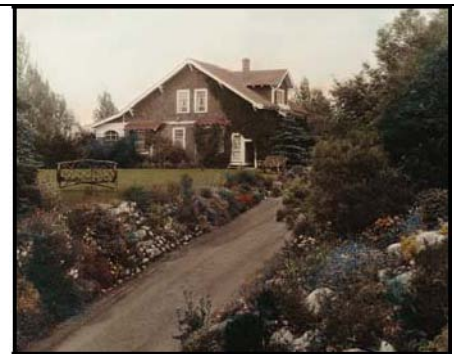
House through the Garden, ca. 1930's

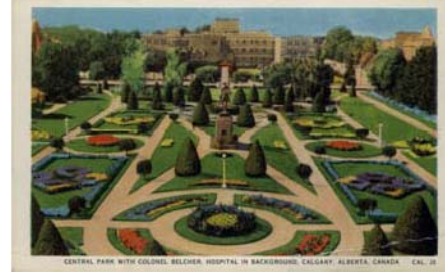
Historic Post Card of Central Memorial Park, ca. 1930's

The central oval with the intricate pattern of paths, planting beds and lawn has evolved slightly over the years. The original granular paths were replaced with asphalt that is now failing.

The spatial organization of the central oval at Central Memorial Park, including the planting beds, lawn, and pathway configuration, is fundamental to illustrating the significance of the site. There was a desire from the stakeholder group to include water features within the park. The decision was made to retain the spatial organization of the oval and replace three historic planting beds with water features. The new additions section includes only six recommendations and two of those are specifically for buildings. Introducing new uses in a way that still retains the significance of an historic site is essential when contemporary pressures identify the site as no longer useful or appropriate. The introduction of new uses could potentially do the most damage to the historic material, so more detail should be offered in the new additions section.

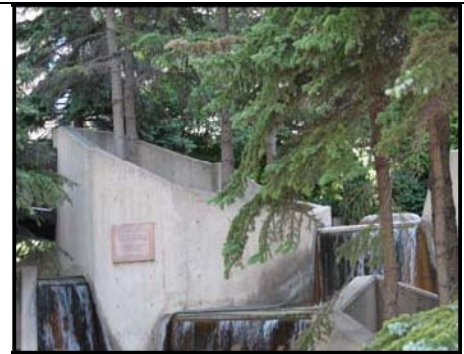
Century Gardens is located in downtown Calgary and can be defined as an expressionism designed park with associated brutalism elements. The 0.5 ha (1.25 acres) park dates from 1975 and was donated to the City of Calgary by the Devonian Foundation as a way to celebrate Calgary's Centennial. The park design was a symbol of Calgary's growth and maturity - the modern form expressed the forward and innovative thinking of Calgary's citizens (Calgary Herald, 1974). The design of Century Gardens was inspired by the nearby Rocky Mountains. The concrete work represents the mountains and, along with the

Century Gardens, 2007

heavy use of flowing water and spruce trees, combine to create an abstract expression of Calgary's surrounding landscape.

The circulation system at Century Gardens includes a set of rock stepping stones that allow a park user to walk over the water. These rocks have been identified as unsafe but the safety consideration section is primarily about meeting codes and does not have any specific recommendations for landscapes. A decision has been made to chain the area, which does alter the circulation pattern, but still retains the historic material.

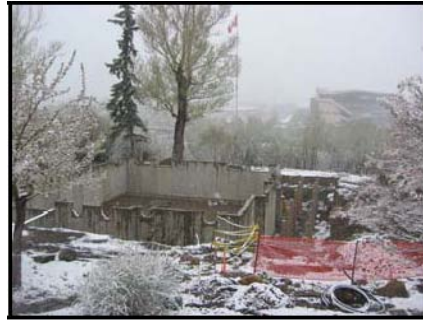
Foundation for reconstructed Cottage at Reader Rock Garden, 2004

The reconstructed cottage was designed to house a small restaurant and classroom space for school and adult programs.

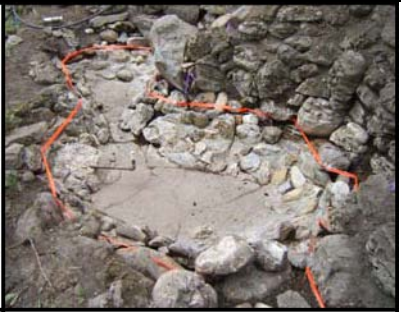
<p>Pond Rehabilitation work, 2004</p>
---	---

<p>The historic water features at Reader Rock Garden were designed as a way of irrigating the adjacent beds. The upper pond would be filled and water would continue down the slope to the lower pond to fill the lower pond. The water would continue to flow, saturating the soil and irrigating the surrounding beds. Historically the system was not recirculating and excess water would continue to flow down the slope and off the site. The Environmental Considerations in the Standards and Guidelines encouraged the repair of existing leaks and the installation of a new, recirculating system.</p>

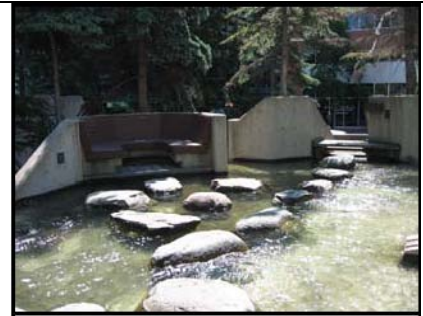
Stepping Stones at Century Gardens, 2007

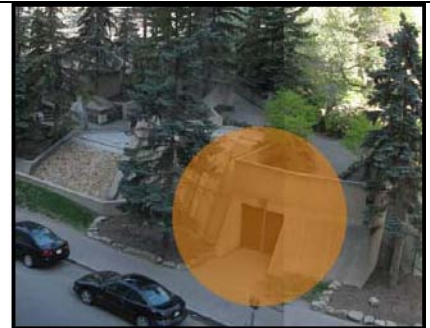
Door to Parks Office at Century Gardens, 2007

The structure at the southwest corner of Century Gardens is viewed by some as a safety concern - the elevated portion from street level and the retreat/respice areas are seen as places where illicit activity can occur. The original impulse was to demolish the structure but referring back to the built features and new additions section within the Standards and Guidelines the decision has been made to alter to original structure to have more surveillance in the park. The Parks office will be opened to create a stronger relationship between the office, the park, and the street. Again the new additions section offered only minor guidance.
